Access Compliance Report

Public Rights-of-Way

(Curb Ramps)

Intersection ID: 10018631	Main Street: AGAVA_LN	Cross Street: N/A	Location: E
ADA ID: 45436CEFD39D	Ramp Type: Perp	Initial Pass/Fail: Pass	Overall Compliance: No
Severity Score: 0			
Codes/Mitigation Info/Possible Solution		Field Measurements/Component Compliance

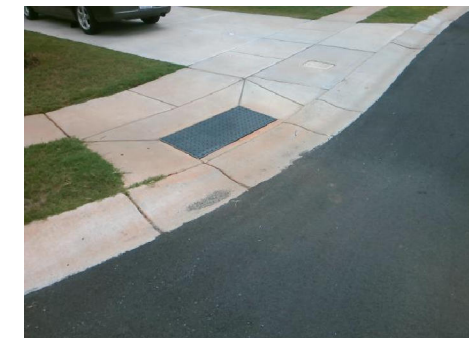
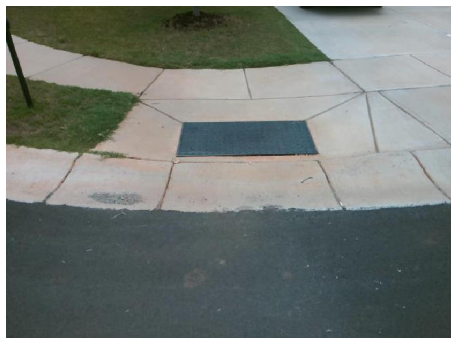
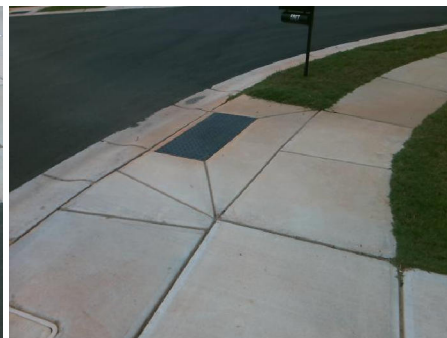
Compliance	Description	Data	Compliance	Description	Data
N/A	Ramp Length (in)	51.0	Yes	Ramp Slope (%)	7.5
Yes	Ramp Width (in)	48.0	Yes	Ramp XSlope (%)	0.9
N/A	Flare Type LT	Sloped	N/A	Flare Type RT	N/A
N/A	Flare Slope LT (%)	5.6	N/A	Flare Slope RT (%)	6.8
N/A	Flare Traversable LT?	No	N/A	Flare Traversable RT?	No
No	Landing Length (in)	42.5	Yes	DWS Provided?	Yes
Yes	Landing Width (in)	48.0	Yes	DWS Contrast?	Yes
No	Landing Slope (%)	3.7	Yes	DWS Length (in)	24.0
No	Landing X Slope (%)	3.5	Yes	DWS Full Width?	Yes
N/A	Landing Curb? (Y/N)	No	No	DWS Offset (in)	4.0
N/A	Shared Landing?	No			
No	Gutter Ponding?	Yes	Yes	Gutter Slope (%)	2.4
Yes	Gutter Lip Ht (in)	0.0	Yes	Gutter X Slope (%)	0.5
N/A	Painted X Walk1?	No	N/A	Painted X Walk2?	N/A
	X Walk 1 Direction	To S		X Walk 2 Direction	N/A
N/A	X Walk 1 Width (in)	N/A	N/A	X Walk 2 Width (in)	N/A
	X Walk 1 Slope (%)	0.4		X Walk 2 Slope (%)	N/A
	X Walk 1 X Slope (%)	1.8		X Walk 2 X Slope (%)	N/A

N/A	Ramp inside XWalk1?	N/A	N/A	Ramp inside XWalk2?	N/A
	Road Slope (%)	N/A	N/A	Clear Space?	Yes
	Road X Slope (%)	N/A	N/A	Clear Space to XWalk (in)	N/A
Yes	Any Obstructions?	No	Yes	Storm Grate/Utility Hazard?	No
	Obstruction Type			Storm Grate/Utility Type	
		N/A			N/A
			Yes	Surface Condition? (G/P)	Good

Possible Solutions:

Remove & Replace Entire Ramp.
