# Access Compliance Report

## Public Rights-of-Way

### (Curb Ramps)

Intersection ID: 23042	Main Street: PARK_RD	Cross Street: MEETING_ST	Location: SW
ADA ID: 45439F2B3889	Ramp Type: PerpDiag	Initial Pass/Fail: Fail	Overall Compliance: No
		Severity Score: 37.5

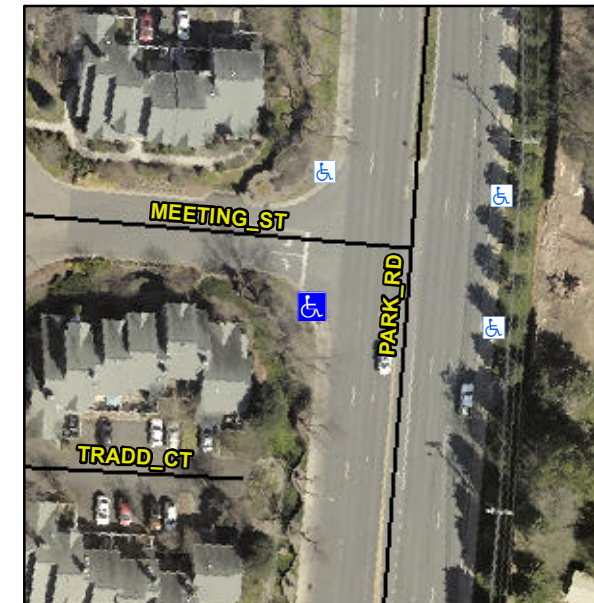
**Not Found, R304.2.2, R304.5.3**

Compliance	Description	Data	Compliance	Description	Data
N/A	Ramp Length (in)	60.0	No	Ramp Slope (%)	11.1
Yes	Ramp Width (in)	48.0	No	Ramp XSlope (%)	9.0
N/A	Flare Type LT	N/A	N/A	Flare Type RT	N/A
N/A	Flare Slope LT (%)	N/A	N/A	Flare Slope RT (%)	N/A
N/A	Flare Traversable LT?	N/A	N/A	Flare Traversable RT?	N/A
N/A	Landing Length (in)	N/A	N/A	DWS Provided?	N/A
N/A	Landing Width (in)	N/A	N/A	DWS Contrast?	N/A
N/A	Landing Slope (%)	N/A	N/A	DWS Length (in)	N/A
N/A	Landing X Slope (%)	N/A	N/A	DWS Full Width?	N/A
N/A	Landing Curb? (Y/N)	N/A	N/A	DWS Offset (in)	N/A
N/A	Shared Landing?	N/A			
N/A	Gutter Ponding?	N/A	N/A	Gutter Slope (%)	N/A
N/A	Gutter Lip Ht (in)	N/A	N/A	Gutter X Slope (%)	N/A
N/A	Painted X Walk1?	No	N/A	Painted X Walk2?	No
	X Walk 1 Direction	To SE		X Walk 2 Direction	To NE
N/A	X Walk 1 Width (in)	N/A	N/A	X Walk 2 Width (in)	N/A
	X Walk 1 Slope (%)	15.6		X Walk 2 Slope (%)	1.4
	X Walk 1 X Slope (%)	6.8		X Walk 2 X Slope (%)	14.7

N/A	Ramp inside XWalk1?	N/A	N/A	Ramp inside XWalk2?	N/A
	Road Slope (%)	9.0	N/A	Clear Space?	N/A
	Road X Slope (%)	12.5	N/A	Clear Space to XWalk (in)	N/A
N/A	Any Obstructions?	N/A	N/A	Storm Grate/Utility Hazard?	N/A
	Obstruction Type			Storm Grate/Utility Type	
		N/A			N/A
			Yes	Surface Condition? (G/P)	Good

**Remove & Replace Curb Ramp With Two New Directional Ramps or Equivalent.**
