# Access Compliance Report

## Public Rights-of-Way

### (Curb Ramps)

| Intersection ID: N/A | Main Street: COPPER_WY | Cross Street: N/A | Location: SW |

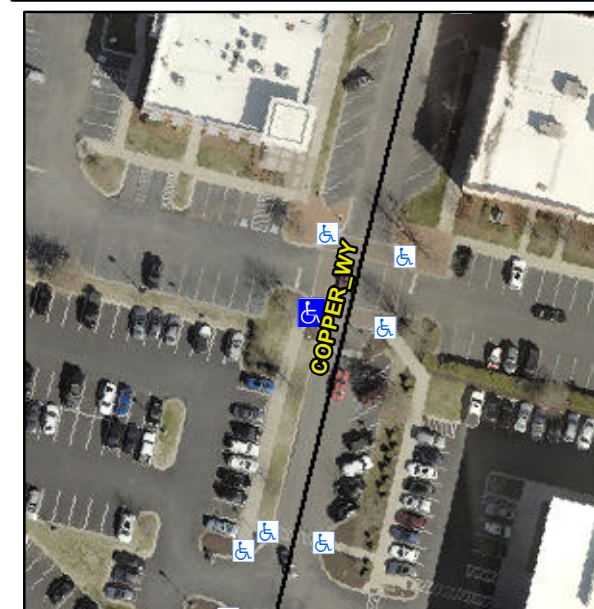
**Not Found, R304.2.2-Perp, R304.3.2-Para, R304.5.3**

| Compliance | Description | Data | Compliance | Description | Data |
|---|---|---|---|---|---|
| No | Landing Slope (%) | 4.6 | Yes | DWS Length (in) | 48.0 |
| Yes | Gutter Lip Ht (in) | 0.0 | No | Gutter X Slope (%) | 2.2 |

**Remove & Replace Curb Ramp With Two New Directional Ramps or Equivalent. Remove & Replace Gutter.**

Total Cost: \$ 3950.00
