# Access Compliance Report

## Public Rights-of-Way

### (Curb Ramps)

Intersection ID: 29188	Main Street: JADE_GLEN_DR	Cross Street: SOUTHERN_SUGAR_DR	Location: SE
ADA ID: 4545BA0E6B3F	Ramp Type: PerpDiag	Initial Pass/Fail: Fail	Overall Compliance: No
Severity Score: 12.5			
Codes/Mitigation Info/Possible Solution		Field Measurements/Component Compliance

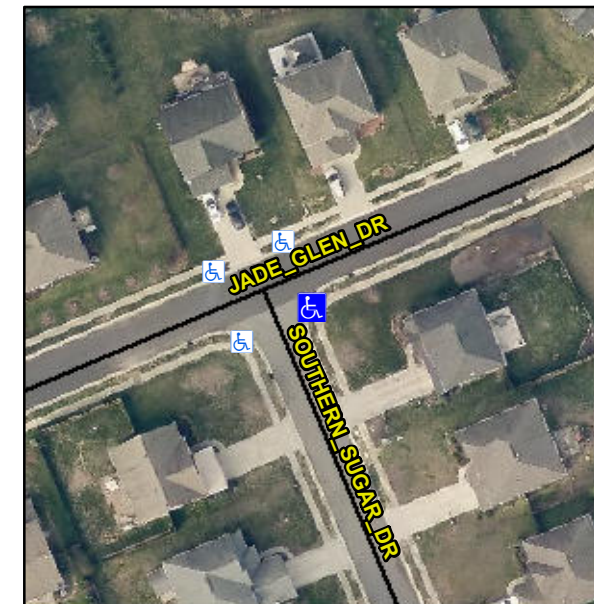
**Not Found, R304.5.3**

Compliance	Description	Data	Compliance	Description	Data
N/A	Ramp Length (in)	49.0	Yes	Ramp Slope (%)	5.4
Yes	Ramp Width (in)	48.0	No	Ramp XSlope (%)	5.1
N/A	Flare Type LT	N/A	N/A	Flare Type RT	N/A
N/A	Flare Slope LT (%)	N/A	N/A	Flare Slope RT (%)	N/A
N/A	Flare Traversable LT?	N/A	N/A	Flare Traversable RT?	N/A
N/A	Landing Length (in)	N/A	N/A	DWS Provided?	N/A
N/A	Landing Width (in)	N/A	N/A	DWS Contrast?	N/A
N/A	Landing Slope (%)	N/A	N/A	DWS Length (in)	N/A
N/A	Landing X Slope (%)	N/A	N/A	DWS Full Width?	N/A
N/A	Landing Curb? (Y/N)	N/A	N/A	DWS Offset (in)	N/A
N/A	Shared Landing?	N/A			
N/A	Gutter Ponding?	N/A	N/A	Gutter Slope (%)	N/A
N/A	Gutter Lip Ht (in)	N/A	N/A	Gutter X Slope (%)	N/A
N/A	Painted X Walk1?	No	N/A	Painted X Walk2?	No
	X Walk 1 Direction	To N		X Walk 2 Direction	To W
N/A	X Walk 1 Width (in)	N/A	N/A	X Walk 2 Width (in)	N/A
	X Walk 1 Slope (%)	2.2		X Walk 2 Slope (%)	3.2
	X Walk 1 X Slope (%)	3.4		X Walk 2 X Slope (%)	2.4

N/A	Ramp inside XWalk1?	N/A	N/A	Ramp inside XWalk2?	N/A
	Road Slope (%)	1.8	N/A	Clear Space?	N/A
	Road X Slope (%)	0.0	N/A	Clear Space to XWalk (in)	N/A
N/A	Any Obstructions?	N/A	N/A	Storm Grate/Utility Hazard?	N/A
	Obstruction Type			Storm Grate/Utility Type	
		N/A			N/A
		Yes		Surface Condition? (G/P)	Good

**Remove & Replace Curb Ramp With Two New Directional Ramps or Equivalent.**

Total Cost: \$ 3200.00
