Access Compliance Report

Public Rights-of-Way

(Curb Ramps)

Intersection ID: 43209	Main Street: PRITCHARD_ST	Cross Street: TILLMAN_RD	Location: W
ADA ID: 454A8D291332	Ramp Type: Perp	Initial Pass/Fail: Fail	Overall Compliance: No
Codes/Mitigation Info/Possible Solution		Field Measurements/Component Compliance	
Severity Score: 13.75

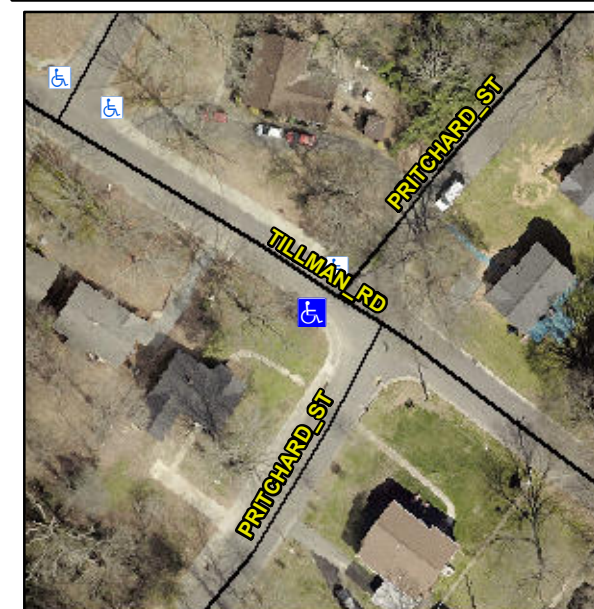
Not Found, R304.2.2, R304.5.3

Compliance	Description	Data	Compliance	Description	Data
N/A	Ramp Length (in)	70.0	No	Ramp Slope (%)	8.5
Yes	Ramp Width (in)	48.0	No	Ramp XSlope (%)	5.0
N/A	Flare Type LT	N/A	N/A	Flare Type RT	N/A
N/A	Flare Slope LT (%)	N/A	N/A	Flare Slope RT (%)	N/A
N/A	Flare Traversable LT?	N/A	N/A	Flare Traversable RT?	N/A
N/A	Landing Length (in)	N/A	N/A	DWS Provided?	N/A
N/A	Landing Width (in)	N/A	N/A	DWS Contrast?	N/A
N/A	Landing Slope (%)	N/A	N/A	DWS Length (in)	N/A
N/A	Landing X Slope (%)	N/A	N/A	DWS Full Width?	N/A
N/A	Landing Curb? (Y/N)	N/A	N/A	DWS Offset (in)	N/A
N/A	Shared Landing?	N/A			
N/A	Gutter Ponding?	N/A	N/A	Gutter Slope (%)	N/A
N/A	Gutter Lip Ht (in)	0.5	N/A	Gutter X Slope (%)	N/A
N/A	Painted X Walk1?	No	N/A	Painted X Walk2?	N/A
	X Walk 1 Direction	To NE		X Walk 2 Direction	N/A
N/A	X Walk 1 Width (in)	N/A	N/A	X Walk 2 Width (in)	N/A
	X Walk 1 Slope (%)	3.0		X Walk 2 Slope (%)	N/A
	X Walk 1 X Slope (%)	4.9		X Walk 2 X Slope (%)	N/A

N/A	Ramp inside XWalk1?	N/A	N/A	Ramp inside XWalk2?	N/A
	Road Slope (%)	N/A	N/A	Clear Space?	N/A
	Road X Slope (%)	N/A	N/A	Clear Space to XWalk (in)	N/A
N/A	Any Obstructions?	N/A	N/A	Storm Grate/Utility Hazard?	N/A
	Obstruction Type			Storm Grate/Utility Type	
		N/A			N/A
		Yes		Surface Condition? (G/P)	Good

Possible Solutions:

Remove & Replace Entire Ramp.

Total Cost: \$ 1850.00
