Access Compliance Report Public Rights-of-Way (Curb Ramps)

Intersection ID: 9489 Main Street: STATESVILLE_AV Cross Street: KOHLER_AV Location: NE

ADA ID: 454D1CCB15A2 Ramp Type: Perp Initial Pass/Fail: Fail Overall Compliance: No Severity Score: 21.25

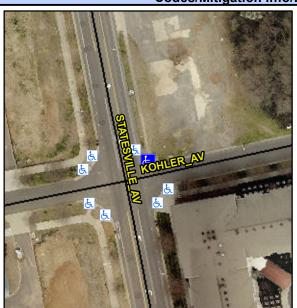
001111	manec Description	Dutu	ООППР	marioc Description	Dutu
N/A	Ramp Length (in)	60.0	No	Ramp Slope (%)	9.0
No	Ramp Width (in)	47.5	Yes	Ramp XSlope (%)	1.3
N/A	Flare Type LT	N/A	N/A	Flare Type RT	N/A
N/A	Flare Slope LT (%)	N/A	N/A	Flare Slope RT (%)	N/A
N/A	Flare Traversable LT?	N/A	N/A	Flare Traversable RT?	N/A
N/A	Landing Length (in)	N/A	N/A	DWS Provided?	N/A
N/A	Landing Width (in)	N/A	N/A	DWS Contrast?	N/A
N/A	Landing Slope (%)	N/A	N/A	DWS Length (in)	N/A
N/A	Landing X Slope (%)	N/A	N/A	DWS Full Width?	N/A
N/A	Landing Curb? (Y/N)	N/A	N/A	DWS Offset (in)	N/A
N/A	Shared Landing?	N/A			
N/A	Gutter Ponding?	N/A	N/A	Gutter Slope (%)	N/A
N/A	Gutter Lip Ht (in)	0.75	N/A	Gutter X Slope (%)	N/A
N/A	Painted X Walk1?	No	N/A	Painted X Walk2?	N/A
	X Walk 1 Direction	To SE		X Walk 2 Direction	N/A
N/A	X Walk 1 Width (in)	N/A	N/A	X Walk 2 Width (in)	N/A
	X Walk 1 Slope (%)	2.1		X Walk 2 Slope (%)	N/A
	X Walk 1 X Slope (%)	3.6		X Walk 2 X Slope (%)	N/A

N/A	Ramp inside XWalk1?	N/A	N/A	Ramp inside XWalk2?	N/A
	Road Slope (%)	N/A	N/A	Clear Space?	N/A
	Road X Slope (%)	N/A	N/A	Clear Space to XWalk (in)	N/A
N/A	Any Obstructions?	N/A	N/A	Storm Grate/Utility Hazard?	N/A
	Obstruction Type		l	Storm Grate/Utility Type	
		N/A			N/A
			Yes	Surface Condition? (G/P)	Good

Possible Solutions:	Compliance Description		
Remove & Replace Entire Ramp.	N/A	N/A Ramp Length (in)	
·	No	Ramp Width (in)	
	N/A	Flare	Type LT
	N/A	Flare	Slope LT (%)
	N/A	Flare	Traversable LT
	N/A	Land	ing Length (in)
Surveyor Notes:	N/A	Land	ing Width (in)
N/A	N/A	Land	ing Slope (%)
	N/A	Land	ing X Slope (%)
	N/A	Land	ing Curb? (Y/N)
	N/A	Share	ed Landing?
PROW/ADA:	N/A	Gutte	er Ponding?
Not Found, R304.5.1, R304.2.2	N/A	Gutte	er Lip Ht (in)
	N/A	Paint	ed X Walk1?
		X Wa	lk 1 Direction
	N/A	X Wa	lk 1 Width (in)
		X Wa	lk 1 Slope (%)
		X Wa	lk 1 X Slope (%

1850.00
