Access Compliance Report

Public Rights-of-Way

(Curb Ramps)

Intersection ID: 18900	Main Street: CLIFTON_MEADOW_DR	Cross Street: TWIN_FALLS_LN	Location: SW
ADA ID: 45539F1A664F	Ramp Type: PerpDiag	Initial Pass/Fail: Fail	Overall Compliance: No
Severity Score: 25			
Codes/Mitigation Info/Possible Solution		Field Measurements/Component Compliance

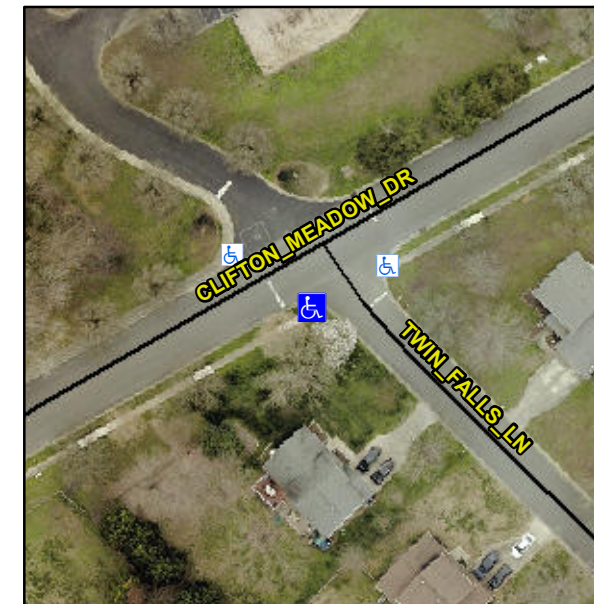
Not Found, R304.5.3

Compliance	Description	Data	Compliance	Description	Data
N/A	Ramp Length (in)	36.0	Yes	Ramp Slope (%)	5.7
Yes	Ramp Width (in)	48.0	No	Ramp XSlope (%)	7.9
N/A	Flare Type LT	N/A	N/A	Flare Type RT	N/A
N/A	Flare Slope LT (%)	N/A	N/A	Flare Slope RT (%)	N/A
N/A	Flare Traversable LT?	N/A	N/A	Flare Traversable RT?	N/A
N/A	Landing Length (in)	N/A	N/A	DWS Provided?	N/A
N/A	Landing Width (in)	N/A	N/A	DWS Contrast?	N/A
N/A	Landing Slope (%)	N/A	N/A	DWS Length (in)	N/A
N/A	Landing X Slope (%)	N/A	N/A	DWS Full Width?	N/A
N/A	Landing Curb? (Y/N)	N/A	N/A	DWS Offset (in)	N/A
N/A	Shared Landing?	N/A			
N/A	Gutter Ponding?	N/A	N/A	Gutter Slope (%)	N/A
N/A	Gutter Lip Ht (in)	N/A	N/A	Gutter X Slope (%)	N/A
N/A	Painted X Walk1?	No	N/A	Painted X Walk2?	No
	X Walk 1 Direction	To NE		X Walk 2 Direction	To NW
N/A	X Walk 1 Width (in)	N/A	N/A	X Walk 2 Width (in)	N/A
	X Walk 1 Slope (%)	6.9		X Walk 2 Slope (%)	2.9
	X Walk 1 X Slope (%)	0.1		X Walk 2 X Slope (%)	9.8

N/A	Ramp inside XWalk1?	N/A	N/A	Ramp inside XWalk2?	N/A
	Road Slope (%)	4.6	N/A	Clear Space?	N/A
	Road X Slope (%)	14.3	N/A	Clear Space to XWalk (in)	N/A
N/A	Any Obstructions?	N/A	N/A	Storm Grate/Utility Hazard?	N/A
	Obstruction Type			Storm Grate/Utility Type	
		N/A			N/A
		Yes		Surface Condition? (G/P)	Good

Remove & Replace Curb Ramp With Two New Directional Ramps or Equivalent.

Total Cost: \$ 3200.00
