Access Compliance Report

Public Rights-of-Way

(Curb Ramps)

Intersection ID: 14195	Main Street: CLEVELAND_AV	Cross Street: EAST_BV	Location: SW
ADA ID: 4558FA6EBD5B	Ramp Type: Directional1	Initial Pass/Fail: Pass	Overall Compliance: No
Severity Score: 0.25			
Codes/Mitigation Info/Possible Solution		Field Measurements/Component Compliance

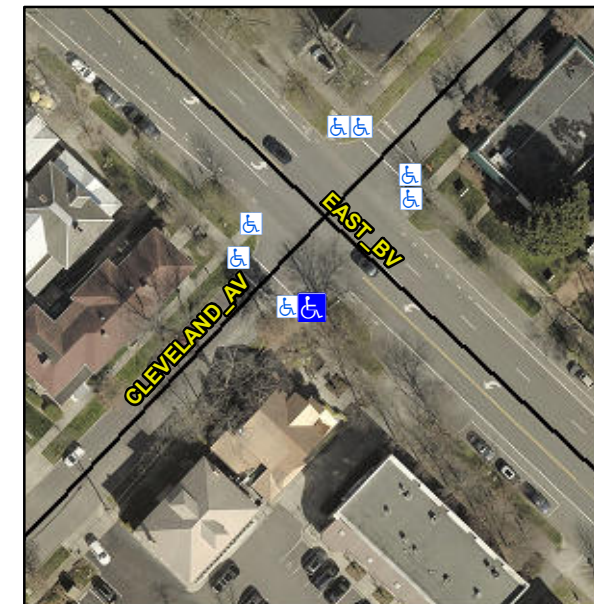
LNDG SLOPE NEGATIVE

Compliance	Description	Data	Compliance	Description	Data
N/A	Ramp Length (in)	76.0	Yes	Grade Break?	Yes
Yes	Ramp Width (in)	71.0	Yes	Grade Break Slope (%)	2.8
Yes	Ramp Slope (%)	4.1	Yes	Grade Break XSlope (%)	1.2
No	Ramp XSlope (%)	2.4			
Yes	Flare Type LT	N/A	Yes	Flare Type RT	N/A
N/A	Flare Slope LT (%)	N/A	N/A	Flare Slope RT (%)	N/A
N/A	Flare Traversable LT?	No	N/A	Flare Traversable RT?	No
No	Landing Length (in)	44.0	Yes	DWS Provided?	Yes
Yes	Landing Width (in)	71.0	Yes	DWS Contrast?	Yes
No	Landing Slope (%)	6.8	Yes	DWS Length (in)	24.0
Yes	Landing X Slope (%)	0.6	Yes	DWS Full Width?	Yes
N/A	Landing Curb? (Y/N)	No	Yes	DWS Offset LT (in)	38.0
N/A	Shared Landing?	No	No	DWS Offset RT (in)	3.0
Yes	Gutter Ponding?	No	Yes	Gutter Slope (%)	4.3
Yes	Gutter Lip Ht (in)	0.0	Yes	Gutter X Slope (%)	1.4
N/A	Painted X Walk1?	No		Road Slope (%)	4.2
	X Walk 1 Direction	To NE		Road X Slope (%)	0.9
	X Walk 1 Width (in)	N/A		Clear Space?	Yes

X Walk 1 Slope (%)	4.2	N/A	Clear Space to XWalk (in)	N/A
	X Walk 1 X Slope (%)	0.9	Yes	Storm Grate/Utility Hazard?	No
N/A	Ramp inside XWalk1?	N/A		Storm Grate/Utility Type	
Yes	Any Obstructions?	No			N/A
	Obstruction Type		Yes	Surface Condition? (G/P)	Good
			N/A	Curb Slope (%)	5.3

Remove & Replace Entire Ramp.
