Intersection ID: N/A	Main Street: PILCHER_DR	Cross Street: VILLAGE_POND_DR	Location:	NE
ADA ID: 455BFD8EA45C	Ramp Type: PerpDiag	Initial Pass/Fail: Fail	Overall Compliance: No	Severity Score: 10

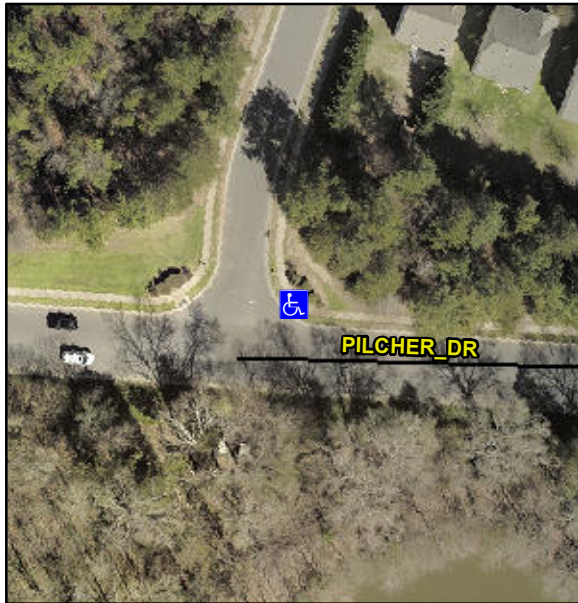
Not Found, R304.5.1, R304.5.3

Compliance	Description	Data	Compliance	Description	Data
N/A	Ramp Length (in)	48.0	Yes	Ramp Slope (%)	7.8
No	Ramp Width (in)	47.0	No	Ramp XSlope (%)	2.5
N/A	Flare Type LT	N/A	N/A	Flare Type RT	N/A
N/A	Flare Slope LT (%)	N/A	N/A	Flare Slope RT (%)	N/A
N/A	Flare Traversable LT?	N/A	N/A	Flare Traversable RT?	N/A
N/A	Landing Length (in)	N/A	N/A	DWS Provided?	N/A
N/A	Landing Width (in)	N/A	N/A	DWS Contrast?	N/A
N/A	Landing Slope (%)	N/A	N/A	DWS Length (in)	N/A
N/A	Landing X Slope (%)	N/A	N/A	DWS Full Width?	N/A
N/A	Landing Curb? (Y/N)	N/A	N/A	DWS Offset (in)	N/A
N/A	Shared Landing?	N/A			
N/A	Gutter Ponding?	N/A	N/A	Gutter Slope (%)	N/A
N/A	Gutter Lip Ht (in)	N/A	N/A	Gutter X Slope (%)	N/A
N/A	Painted X Walk1?	No	N/A	Painted X Walk2?	No
	X Walk 1 Direction	To NW		X Walk 2 Direction	To S
N/A	X Walk 1 Width (in)	N/A	N/A	X Walk 2 Width (in)	N/A
	X Walk 1 Slope (%)	3.6		X Walk 2 Slope (%)	4.0
	X Walk 1 X Slope (%)	3.2		X Walk 2 X Slope (%)	1.4

N/A	Ramp inside XWalk1?	N/A	N/A	Ramp inside XWalk2?	N/A
	Road Slope (%)	1.2	N/A	Clear Space?	N/A
	Road X Slope (%)	6.5	N/A	Clear Space to XWalk (in)	N/A
N/A	Any Obstructions?	N/A	N/A	Storm Grate/Utility Hazard?	N/A
	Obstruction Type			Storm Grate/Utility Type	
		N/A			N/A
			Yes	Surface Condition? (G/P)	Good

Remove & Replace Curb Ramp With Two New Directional Ramps or Equivalent.
