Access Compliance Report

Public Rights-of-Way

(Curb Ramps)

Intersection ID: 31591	Main Street: HUGUE_WY	Cross Street: BLUE_BRIDGE_CT	Location: SE
ADA ID: 45628DD58E47	Ramp Type: PerpDiag	Initial Pass/Fail: Fail	Overall Compliance: No
Severity Score: 12.5			
Codes/Mitigation Info/Possible Solution		Field Measurements/Component Compliance

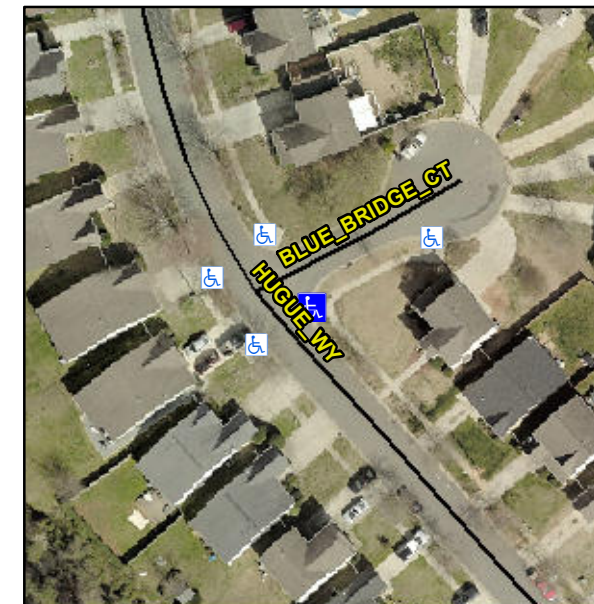
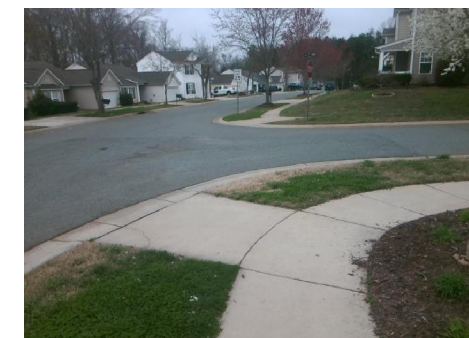
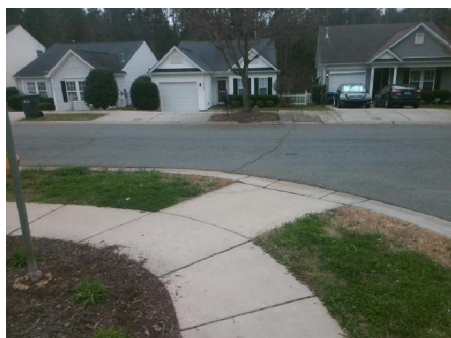
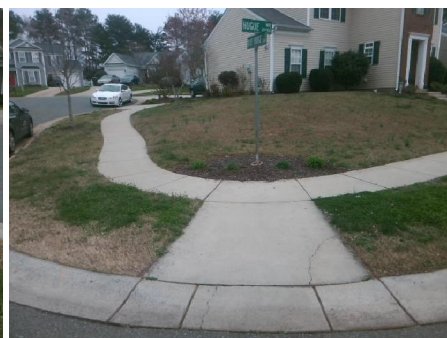
Not Found, R304.2.2

Compliance	Description	Data	Compliance	Description	Data
N/A	Ramp Length (in)	81.0	No	Ramp Slope (%)	8.4
Yes	Ramp Width (in)	67.0	Yes	Ramp XSlope (%)	1.0
N/A	Flare Type LT	N/A	N/A	Flare Type RT	N/A
N/A	Flare Slope LT (%)	N/A	N/A	Flare Slope RT (%)	N/A
N/A	Flare Traversable LT?	N/A	N/A	Flare Traversable RT?	N/A
N/A	Landing Length (in)	N/A	N/A	DWS Provided?	N/A
N/A	Landing Width (in)	N/A	N/A	DWS Contrast?	N/A
N/A	Landing Slope (%)	N/A	N/A	DWS Length (in)	N/A
N/A	Landing X Slope (%)	N/A	N/A	DWS Full Width?	N/A
N/A	Landing Curb? (Y/N)	N/A	N/A	DWS Offset (in)	N/A
N/A	Shared Landing?	N/A			
N/A	Gutter Ponding?	N/A	N/A	Gutter Slope (%)	N/A
N/A	Gutter Lip Ht (in)	N/A	N/A	Gutter X Slope (%)	N/A
N/A	Painted X Walk1?	No	N/A	Painted X Walk2?	No
	X Walk 1 Direction	To NW		X Walk 2 Direction	To SW
N/A	X Walk 1 Width (in)	N/A	N/A	X Walk 2 Width (in)	N/A
	X Walk 1 Slope (%)	1.0		X Walk 2 Slope (%)	0.2
	X Walk 1 X Slope (%)	1.0		X Walk 2 X Slope (%)	0.8

N/A	Ramp inside XWalk1?	N/A	N/A	Ramp inside XWalk2?	N/A
	Road Slope (%)	0.2	N/A	Clear Space?	N/A
	Road X Slope (%)	1.3	N/A	Clear Space to XWalk (in)	N/A
N/A	Any Obstructions?	N/A	N/A	Storm Grate/Utility Hazard?	N/A
	Obstruction Type			Storm Grate/Utility Type	
		N/A			N/A
			Yes	Surface Condition? (G/P)	Good

Remove & Replace Curb Ramp With Two New Directional Ramps or Equivalent.
