# Access Compliance Report

## Public Rights-of-Way

Intersection ID: 9599	Main Street: CLIFTON_ST	Cross Street: OAKLAWN_AV	Location: SW
ADA ID: 456563BBA709	Ramp Type: PerpDiag	Initial Pass/Fail: Fail	Overall Compliance: No
		Severity Score: 10

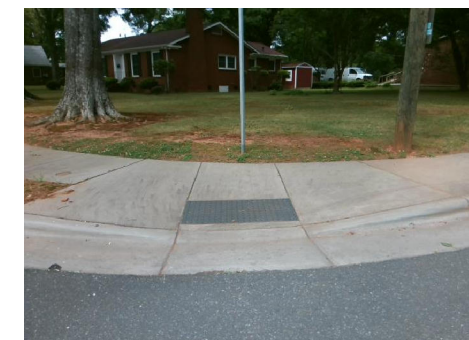
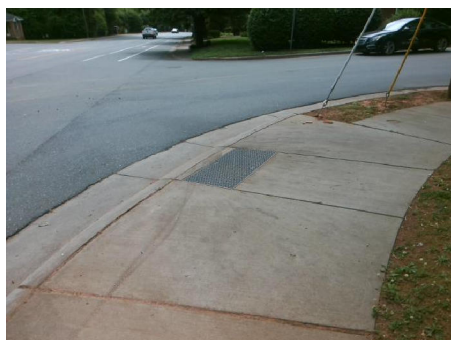
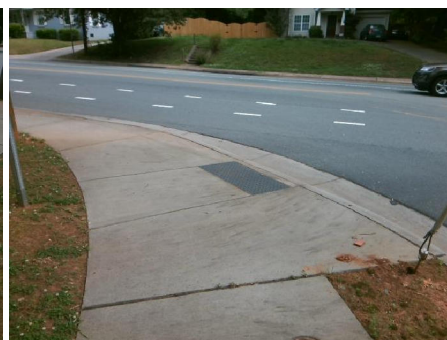
**Not Found, R304.5.1, R304.5.3**

Compliance	Description	Data	Compliance	Description	Data
N/A	Ramp Length (in)	88.0	Yes	Ramp Slope (%)	6.3
No	Ramp Width (in)	46.5	No	Ramp XSlope (%)	3.1
N/A	Flare Type LT	N/A	N/A	Flare Type RT	N/A
N/A	Flare Slope LT (%)	N/A	N/A	Flare Slope RT (%)	N/A
N/A	Flare Traversable LT?	N/A	N/A	Flare Traversable RT?	N/A
N/A	Landing Length (in)	N/A	N/A	DWS Provided?	N/A
N/A	Landing Width (in)	N/A	N/A	DWS Contrast?	N/A
N/A	Landing Slope (%)	N/A	N/A	DWS Length (in)	N/A
N/A	Landing X Slope (%)	N/A	N/A	DWS Full Width?	N/A
N/A	Landing Curb? (Y/N)	N/A	N/A	DWS Offset (in)	N/A
N/A	Shared Landing?	N/A			
N/A	Gutter Ponding?	N/A	N/A	Gutter Slope (%)	N/A
N/A	Gutter Lip Ht (in)	N/A	N/A	Gutter X Slope (%)	N/A
N/A	Painted X Walk1?	No	N/A	Painted X Walk2?	No
	X Walk 1 Direction	To SE		X Walk 2 Direction	To NE
N/A	X Walk 1 Width (in)	N/A	N/A	X Walk 2 Width (in)	N/A
	X Walk 1 Slope (%)	3.8		X Walk 2 Slope (%)	1.2
	X Walk 1 X Slope (%)	1.7		X Walk 2 X Slope (%)	2.7

N/A	Ramp inside XWalk1?	N/A	N/A	Ramp inside XWalk2?	N/A
	Road Slope (%)	1.8	N/A	Clear Space?	N/A
	Road X Slope (%)	0.2	N/A	Clear Space to XWalk (in)	N/A
N/A	Any Obstructions?	N/A	N/A	Storm Grate/Utility Hazard?	N/A
	Obstruction Type			Storm Grate/Utility Type	
		N/A			N/A
			Yes	Surface Condition? (G/P)	Good

**Remove & Replace Curb Ramp With Two New Directional Ramps or Equivalent.**
