Access Compliance Report

Public Rights-of-Way

(Curb Ramps)

Intersection ID: 31905	Main Street: PALOMAR_MOUNTAIN_DR	Cross Street: STOWE_DERBY_DR	Location: NW
ADA ID: 457791E86B0F	Ramp Type: BlendTrans1	Initial Pass/Fail: Fail	Overall Compliance: No
		Severity Score: 10

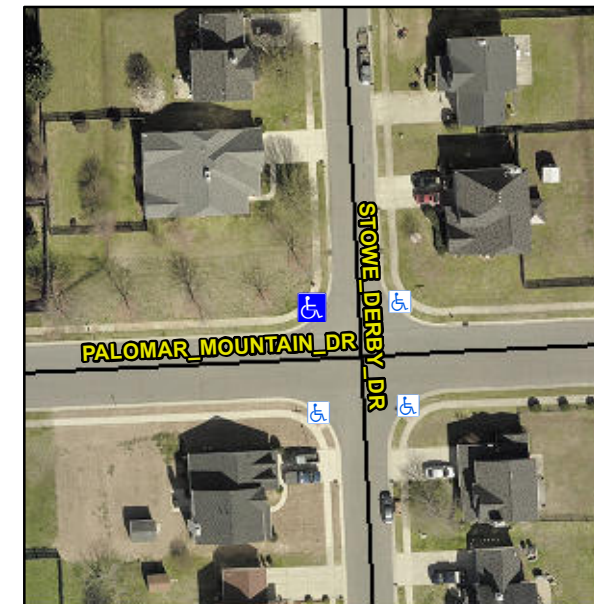
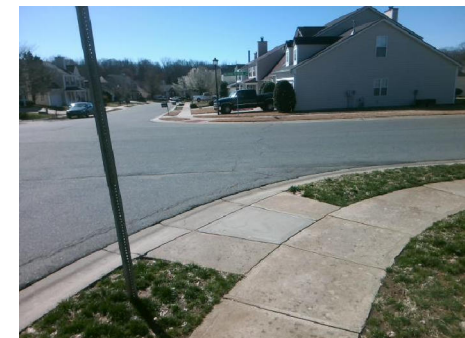
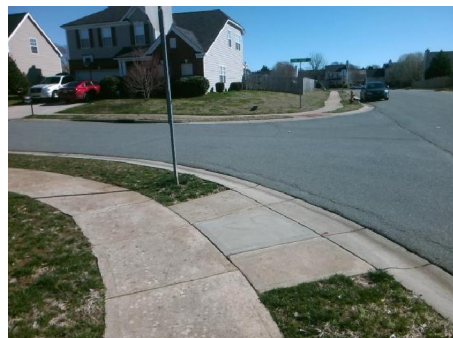
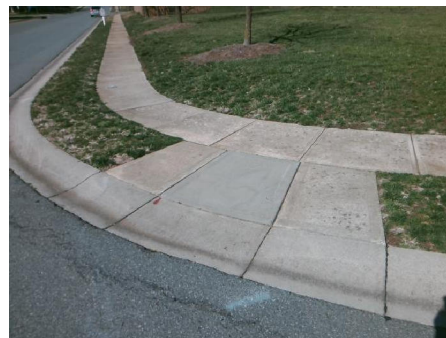
Not Found, R304.5.1, R304.5.3

Compliance	Description	Data	Compliance	Description	Data
N/A	Ramp Length (in)	49.0	Yes	BlendTrans Slope (%)	4.7
No	Ramp Width (in)	37.5	No	BlendTrans XSlope (%)	2.6
N/A	Flare Type LT	N/A	N/A	Flare Type RT	N/A
N/A	Flare Slope LT (%)	N/A	N/A	Flare Slope RT (%)	N/A
N/A	Flare Traversable LT?	N/A	N/A	Flare Traversable RT?	N/A
N/A	Landing Length (in)	N/A	N/A	DWS Provided?	N/A
N/A	Landing Width (in)	N/A	N/A	DWS Contrast?	N/A
N/A	Landing Slope (%)	N/A	N/A	DWS Length (in)	N/A
N/A	Landing X Slope (%)	N/A	N/A	DWS Full Width?	N/A
N/A	Landing Curb? (Y/N)	N/A	N/A	DWS Offset (in)	N/A
N/A	Shared Landing?	N/A			
N/A	Gutter Ponding?	N/A	N/A	Gutter Slope (%)	N/A
N/A	Gutter Lip Ht (in)	N/A	N/A	Gutter X Slope (%)	N/A
N/A	Painted X Walk1?	No	N/A	Painted X Walk2?	No
	X Walk 1 Direction	To S		X Walk 2 Direction	To E
	X Walk 1 Width (in)	N/A		X Walk 2 Width (in)	N/A
	X Walk 1 Slope (%)	2.8		X Walk 2 Slope (%)	1.6
	X Walk 1 X Slope (%)	0.3		X Walk 2 X Slope (%)	1.8

N/A	Ramp inside XWalk1?	N/A	N/A	Ramp inside XWalk2?	N/A
	Road Slope (%)	1.9		Clear Space?	N/A
	Road X Slope (%)	0.3	N/A	Clear Space to XWalk (in)	N/A
N/A	Any Obstructions?	N/A	N/A	Storm Grate/Utility Hazard?	N/A
	Obstruction Type			Storm Grate/Utility Type	
		N/A			N/A
			Yes	Surface Condition? (G/P)	Good
			No	Curb Slope (%)	5.8

Remove & Replace Curb Ramp With Two New Directional Ramps or Equivalent.
