# Access Compliance Report

## Public Rights-of-Way

### (Curb Ramps)

Intersection ID: 42646	Main Street: E_4TH_ST	Cross Street: S_TORRENCE_ST	Location: SE
ADA ID: 457C1C550BBD	Ramp Type: PerpDiag	Initial Pass/Fail: Fail	Overall Compliance: No
Severity Score: 12.5			
Codes/Mitigation Info/Possible Solution		Field Measurements/Component Compliance

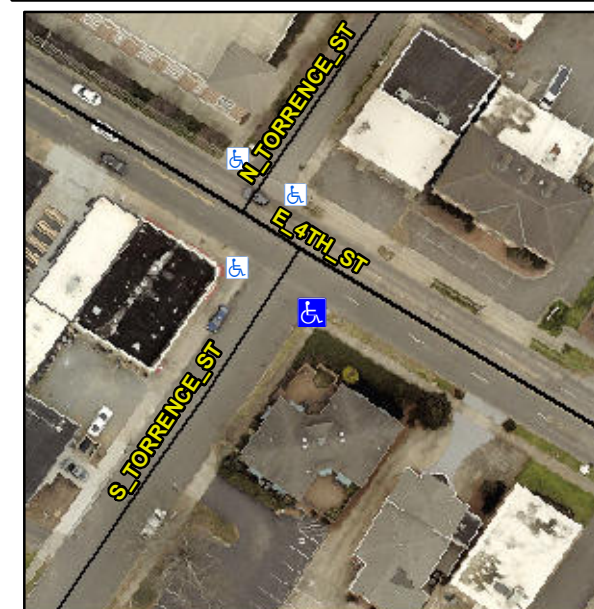
**Not Found, R304.2.2**

Compliance	Description	Data	Compliance	Description	Data
N/A	Ramp Length (in)	69.5	No	Ramp Slope (%)	8.6
Yes	Ramp Width (in)	57.0	Yes	Ramp XSlope (%)	0.0
N/A	Flare Type LT	N/A	N/A	Flare Type RT	N/A
N/A	Flare Slope LT (%)	N/A	N/A	Flare Slope RT (%)	N/A
N/A	Flare Traversable LT?	N/A	N/A	Flare Traversable RT?	N/A
N/A	Landing Length (in)	N/A	N/A	DWS Provided?	N/A
N/A	Landing Width (in)	N/A	N/A	DWS Contrast?	N/A
N/A	Landing Slope (%)	N/A	N/A	DWS Length (in)	N/A
N/A	Landing X Slope (%)	N/A	N/A	DWS Full Width?	N/A
N/A	Landing Curb? (Y/N)	N/A	N/A	DWS Offset (in)	N/A
N/A	Shared Landing?	N/A			
N/A	Gutter Ponding?	N/A	N/A	Gutter Slope (%)	N/A
N/A	Gutter Lip Ht (in)	N/A	N/A	Gutter X Slope (%)	N/A
N/A	Painted X Walk1?	No	N/A	Painted X Walk2?	No
	X Walk 1 Direction	To NE		X Walk 2 Direction	To NW
N/A	X Walk 1 Width (in)	N/A	N/A	X Walk 2 Width (in)	N/A
	X Walk 1 Slope (%)	1.7		X Walk 2 Slope (%)	0.7
	X Walk 1 X Slope (%)	0.2		X Walk 2 X Slope (%)	0.6

N/A	Ramp inside XWalk1?	N/A	N/A	Ramp inside XWalk2?	N/A
	Road Slope (%)	0.9	N/A	Clear Space?	N/A
	Road X Slope (%)	0.2	N/A	Clear Space to XWalk (in)	N/A
N/A	Any Obstructions?	N/A	N/A	Storm Grate/Utility Hazard?	N/A
	Obstruction Type			Storm Grate/Utility Type	
		N/A			N/A
			Yes	Surface Condition? (G/P)	Good

Possible Solutions:

**Remove & Replace Curb Ramp With Two New Directional Ramps or Equivalent.**

Total Cost: \$ 3200.00
