# Access Compliance Report

## Public Rights-of-Way

### (Curb Ramps)

Intersection ID: 50271	Main Street: CLANTON_RD	Cross Street: SOUTH_BV	Location: SE
ADA ID: 45818AD5D184	Ramp Type: Combination2	Initial Pass/Fail: Fail	Overall Compliance: No
Codes/Mitigation Info/Possible Solution		Field Measurements/Component Compliance	
Severity Score: 25

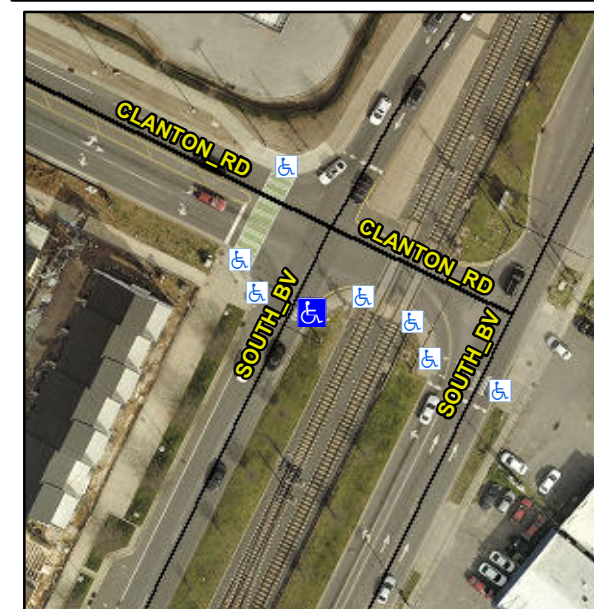
**NO LNDG**

**R304.5.3, R304.3.2**

Compliance	Description	Data	Compliance	Description	Data
N/A	Ramp Length LT (in)	44.0	N/A	Ramp Length RT (in)	N/A
Yes	Ramp Width LT (in)	68.0	N/A	Ramp Width RT (in)	N/A
No	Ramp Slope LT (%)	10.8	N/A	Ramp Slope RT (%)	N/A
No	Ramp XSlope LT (%)	6.0	N/A	Ramp XSlope RT (%)	N/A
N/A	Ramp Length (in)	72.0	Yes	Ramp Slope (%)	5.2
Yes	Ramp Width (in)	48.0	No	Ramp XSlope (%)	5.7
N/A	Flare Type LT	N/A	N/A	Flare Type RT	N/A
N/A	Flare Slope LT (%)	N/A	N/A	Flare Slope RT (%)	N/A
N/A	Flare Traversable LT?	N/A	N/A	Flare Traversable RT?	N/A
N/A	Landing Length (in)	N/A	N/A	DWS Provided?	N/A
N/A	Landing Width (in)	N/A	N/A	DWS Contrast?	N/A
N/A	Landing Slope (%)	N/A	N/A	DWS Length (in)	N/A
N/A	Landing X Slope (%)	N/A	N/A	DWS Full Width?	N/A
N/A	Landing Curb? (Y/N)	N/A	N/A	DWS Offset (in)	N/A
N/A	Shared Landing?	N/A			
N/A	Gutter Ponding?	N/A	N/A	Gutter Slope (%)	N/A
N/A	Gutter Lip Ht (in)	N/A	N/A	Gutter X Slope (%)	N/A
N/A	Painted X Walk1?	Yes	N/A	Painted X Walk2?	N/A

**Remove & Replace Entire Ramp.**
