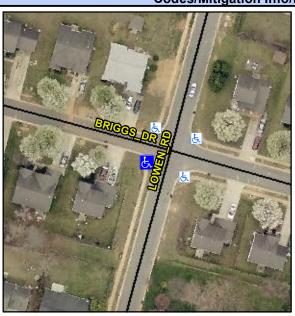
Intersection ID: 4727 Main Street: BRIGGS DR Cross Street: LOWEN_RD Location: SW **ADA ID: 458B224CBCFF** Ramp Type: PerpDiag Initial Pass/Fail: Fail **Overall Compliance: No Severity Score:** 72.5

Field Measurements/Component Compliance							
	Compliance Description		Data	Compliance Description		escription	Data
	N/A	Ramp Length (in)	48.0	No	Ramp S	lope (%)	11.8
	No	Ramp Width (in)	31.0	No	Ramp X	Slope (%)	8.1
	N/A	Flare Type LT	N/A	N/A	Flare Ty	pe RT	N/A
	N/A	Flare Slope LT (%)	N/A	N/A	Flare Sl	ope RT (%)	N/A
	N/A	Flare Traversable LT?	N/A	N/A	Flare Tra	aversable RT?	N/A
	N/A	Landing Length (in)	N/A	N/A	DWS Pr	ovided?	N/A
	N/A	Landing Width (in)	N/A	N/A	DWS Co	ontrast?	N/A
	N/A	Landing Slope (%)	N/A	N/A	DWS Le	ength (in)	N/A
	N/A	Landing X Slope (%)	N/A	N/A	DWS Fu	ıll Width?	N/A
	N/A	Landing Curb? (Y/N)	N/A	N/A	DWS Of	ffset (in)	N/A
	N/A	Shared Landing?	N/A				
	N/A	Gutter Ponding?	N/A	N/A	Gutter S	Slope (%)	N/A
	N/A	Gutter Lip Ht (in)	N/A	N/A	Gutter X	(Slope (%)	N/A
	N/A	Painted X Walk1?	No	N/A	Painted	X Walk2?	No
		X Walk 1 Direction	To SE		X Walk 2	2 Direction	To NE
	N/A	X Walk 1 Width (in)	N/A	N/A	X Walk 2	2 Width (in)	N/A

X Walk 1 Slope (%)	2.9		X Walk 2	2 Slope (%)	8.1
		X Walk 1 X Slope (%)	7.8		X Walk 2	2 X Slope (%)	4.0
	N/A	Ramp inside XWalk1?	N/A	N/A	Ramp in	nside XWalk2?	N/A
		Road Slope (%)	6.4	N/A	Clear Sp	pace?	N/A
		Road X Slope (%)	2.4	N/A	Clear Sp	pace to XWalk (in)	N/A
	N/A	Any Obstructions?	N/A	N/A	Storm G	Grate/Utility Hazard?	N/A
		Obstruction Type			Storm G	Grate/Utility Type	
			N/A				N/A
				Yes	Surface	Condition? (G/P)	Good
œ.		8

LOWEN RD None **BRIGGS DR** StopSign Possible Solutions: Remove & Replace Curb Ramp With Two New Directional Ramps or Equivalent. Surveyor Notes: N/A PROW/ADA: Not Found, R304.5.1, R304.2.2, R304.5.3
