# Access Compliance Report

## Public Rights-of-Way

### (Curb Ramps)

Intersection ID: 44757	Main Street: BONNER_BRIDGE_CT	Cross Street: KINGS_PARADE_BV	Location: SE
ADA ID: 458BFEA8E6BC	Ramp Type: PerpDiag	Initial Pass/Fail: Fail	Overall Compliance: No
Severity Score: 8.75			
Codes/Mitigation Info/Possible Solution		Field Measurements/Component Compliance

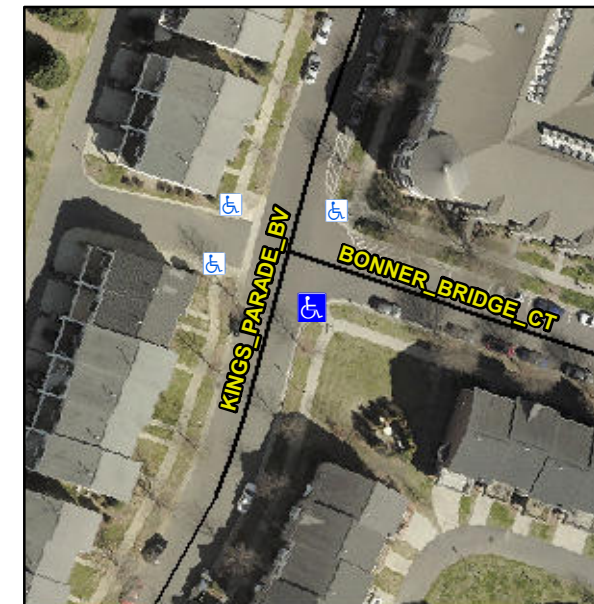
PROW/ADA:

**Not Found, R304.5.1**

Compliance	Description	Data	Compliance	Description	Data
N/A	Ramp Length (in)	97.0	Yes	Ramp Slope (%)	5.2
No	Ramp Width (in)	46.5	Yes	Ramp XSlope (%)	0.4
N/A	Flare Type LT	N/A	N/A	Flare Type RT	N/A
N/A	Flare Slope LT (%)	N/A	N/A	Flare Slope RT (%)	N/A
N/A	Flare Traversable LT?	N/A	N/A	Flare Traversable RT?	N/A
N/A	Landing Length (in)	N/A	N/A	DWS Provided?	N/A
N/A	Landing Width (in)	N/A	N/A	DWS Contrast?	N/A
N/A	Landing Slope (%)	N/A	N/A	DWS Length (in)	N/A
N/A	Landing X Slope (%)	N/A	N/A	DWS Full Width?	N/A
N/A	Landing Curb? (Y/N)	N/A	N/A	DWS Offset (in)	N/A
N/A	Shared Landing?	N/A			
N/A	Gutter Ponding?	N/A	N/A	Gutter Slope (%)	N/A
N/A	Gutter Lip Ht (in)	N/A	N/A	Gutter X Slope (%)	N/A
N/A	Painted X Walk1?	No	N/A	Painted X Walk2?	No
	X Walk 1 Direction	To NE		X Walk 2 Direction	To NW
N/A	X Walk 1 Width (in)	N/A	N/A	X Walk 2 Width (in)	N/A
	X Walk 1 Slope (%)	0.7		X Walk 2 Slope (%)	1.8
	X Walk 1 X Slope (%)	1.5		X Walk 2 X Slope (%)	0.4

N/A	Ramp inside XWalk1?	N/A	N/A	Ramp inside XWalk2?	N/A
	Road Slope (%)	1.8	N/A	Clear Space?	N/A
	Road X Slope (%)	0.3	N/A	Clear Space to XWalk (in)	N/A
N/A	Any Obstructions?	N/A	N/A	Storm Grate/Utility Hazard?	N/A
	Obstruction Type			Storm Grate/Utility Type	
		N/A			N/A
			Yes	Surface Condition? (G/P)	Good

Possible Solutions:

**Remove & Replace Curb Ramp With Two New Directional Ramps or Equivalent.**

Total Cost: \$ 3200.00
