Access Compliance Report

Public Rights-of-Way

(Curb Ramps)

Intersection ID: 17140	Main Street: S_WENDOVER_RD	Cross Street: SEDGEWOOD_CR	Location: NW
ADA ID: 4591D28F3194	Ramp Type: PerpDiag	Initial Pass/Fail: Fail	Overall Compliance: No
Severity Score: 46.25			
Codes/Mitigation Info/Possible Solution		Field Measurements/Component Compliance

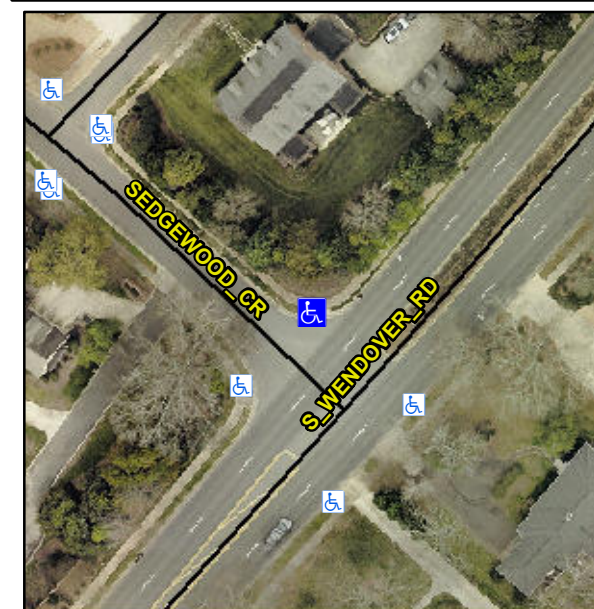
Not Found, R304.5.1, R304.2.2, R304.5.3

Compliance	Description	Data	Compliance	Description	Data
N/A	Ramp Length (in)	43.0	No	Ramp Slope (%)	13.6
No	Ramp Width (in)	40.0	No	Ramp XSlope (%)	5.8
N/A	Flare Type LT	N/A	N/A	Flare Type RT	N/A
N/A	Flare Slope LT (%)	N/A	N/A	Flare Slope RT (%)	N/A
N/A	Flare Traversable LT?	N/A	N/A	Flare Traversable RT?	N/A
N/A	Landing Length (in)	N/A	N/A	DWS Provided?	N/A
N/A	Landing Width (in)	N/A	N/A	DWS Contrast?	N/A
N/A	Landing Slope (%)	N/A	N/A	DWS Length (in)	N/A
N/A	Landing X Slope (%)	N/A	N/A	DWS Full Width?	N/A
N/A	Landing Curb? (Y/N)	N/A	N/A	DWS Offset (in)	N/A
N/A	Shared Landing?	N/A			
N/A	Gutter Ponding?	N/A	N/A	Gutter Slope (%)	N/A
N/A	Gutter Lip Ht (in)	N/A	N/A	Gutter X Slope (%)	N/A
N/A	Painted X Walk1?	No	N/A	Painted X Walk2?	No
	X Walk 1 Direction	To SW		X Walk 2 Direction	To SE
N/A	X Walk 1 Width (in)	N/A	N/A	X Walk 2 Width (in)	N/A
	X Walk 1 Slope (%)	2.8		X Walk 2 Slope (%)	1.0
	X Walk 1 X Slope (%)	1.7		X Walk 2 X Slope (%)	3.1

N/A	Ramp inside XWalk1?	N/A	N/A	Ramp inside XWalk2?	N/A
	Road Slope (%)	3.6	N/A	Clear Space?	N/A
	Road X Slope (%)	1.0	N/A	Clear Space to XWalk (in)	N/A
N/A	Any Obstructions?	N/A	N/A	Storm Grate/Utility Hazard?	N/A
	Obstruction Type			Storm Grate/Utility Type	
		N/A			N/A
			Yes	Surface Condition? (G/P)	Good

Possible Solutions:

Remove & Replace Curb Ramp With Two New Directional Ramps or Equivalent.
