# Access Compliance Report

## Public Rights-of-Way

### (Curb Ramps)

| Intersection ID: 50464 | Main Street: LENOX_POINTE_DR | Cross Street: SANDY_PORTER_RD | Location: NE |

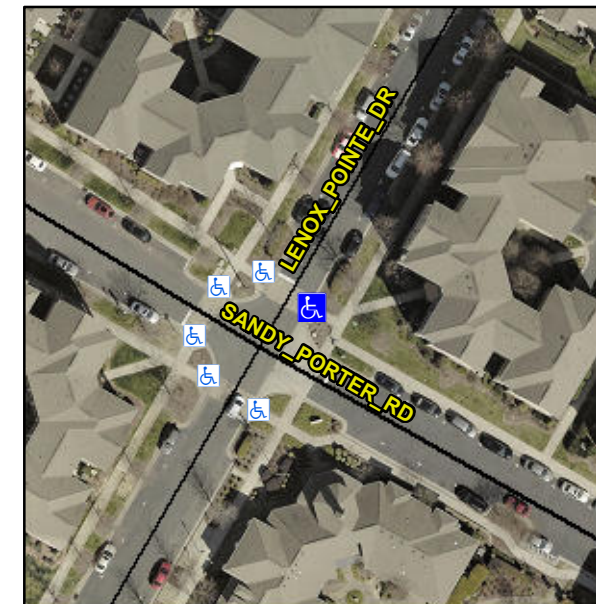
Surveyor Notes:

**XWALK PAVERS, NO PAINT**

| Compliance | Description | Data | Compliance | Description | Data |
|---|---|---|---|---|---|
| No | Landing Slope (%) | 2.3 | Yes | DWS Length (in) | 24.0 |
| N/A | Landing Curb? (Y/N) | No | No | DWS Offset (in) | 5.0 |
| Yes | Gutter Ponding? | No | No | Gutter Slope (%) | 6.5 |

Possible Solutions:

**Remove & Replace Curb Ramp With Two New Directional Ramps or Equivalent. Remove & Replace Gutter.**

**R304.2.2-Perp, R304.3.2-Para, R305.2, R304.5.4**
