# Access Compliance Report

## Public Rights-of-Way (Curb Ramps)

Intersection ID: 54318	Main Street: CANTERBURY_CASTLE_DR	Cross Street: BELMONT_MANSION_DR	Location: SW
ADA ID: 45A30419C707	Ramp Type: Perp	Initial Pass/Fail: Fail	Overall Compliance: No
Severity Score: 12.5			
Codes/Mitigation Info/Possible Solution		Field Measurements/Component Compliance

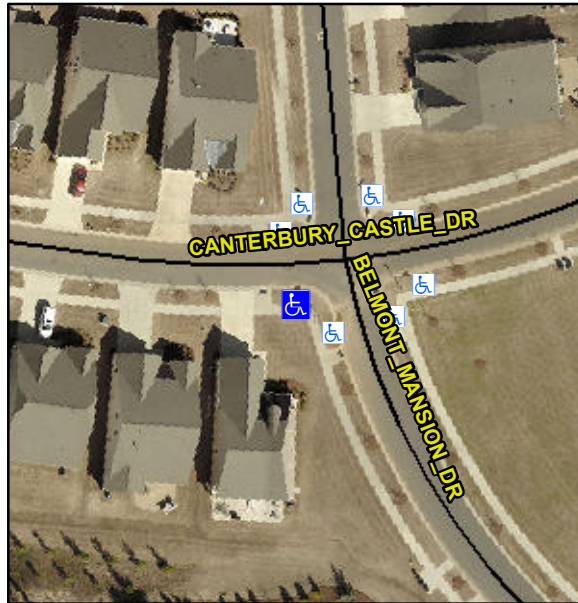
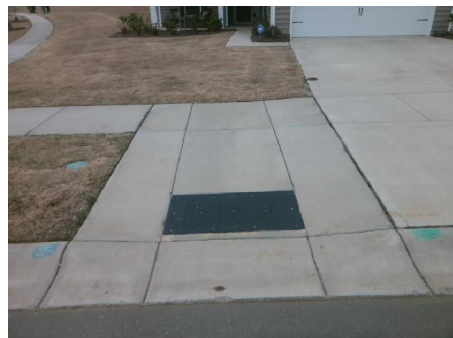
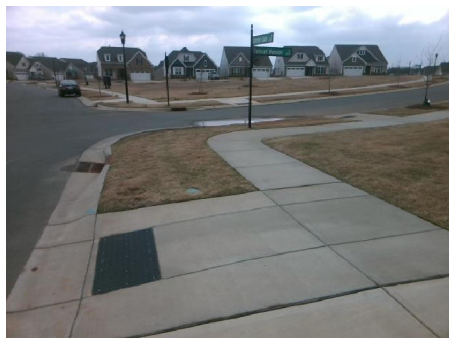
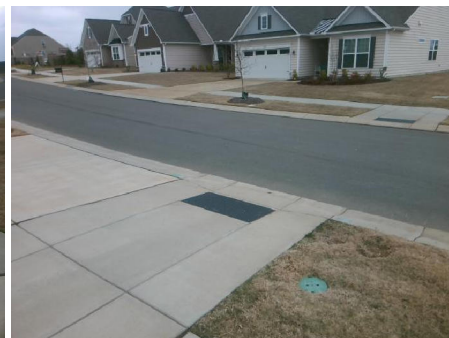
Compliance	Description	Data	Compliance	Description	Data
N/A	Ramp Length (in)	95.0	No	Ramp Slope (%)	8.8
Yes	Ramp Width (in)	48.0	Yes	Ramp XSlope (%)	1.0
N/A	Flare Type LT	N/A	N/A	Flare Type RT	N/A
N/A	Flare Slope LT (%)	N/A	N/A	Flare Slope RT (%)	N/A
N/A	Flare Traversable LT?	N/A	N/A	Flare Traversable RT?	N/A
N/A	Landing Length (in)	N/A	N/A	DWS Provided?	N/A
N/A	Landing Width (in)	N/A	N/A	DWS Contrast?	N/A
N/A	Landing Slope (%)	N/A	N/A	DWS Length (in)	N/A
N/A	Landing X Slope (%)	N/A	N/A	DWS Full Width?	N/A
N/A	Landing Curb? (Y/N)	N/A	N/A	DWS Offset (in)	N/A
N/A	Shared Landing?	N/A			
N/A	Gutter Ponding?	N/A	N/A	Gutter Slope (%)	N/A
N/A	Gutter Lip Ht (in)	N/A	N/A	Gutter X Slope (%)	N/A
N/A	Painted X Walk1?	No	N/A	Painted X Walk2?	N/A
	X Walk 1 Direction	To N		X Walk 2 Direction	N/A
N/A	X Walk 1 Width (in)	N/A	N/A	X Walk 2 Width (in)	N/A
	X Walk 1 Slope (%)	3.0		X Walk 2 Slope (%)	N/A
	X Walk 1 X Slope (%)	0.7		X Walk 2 X Slope (%)	N/A

N/A	Ramp inside XWalk1?	N/A	N/A	Ramp inside XWalk2?	N/A
	Road Slope (%)	N/A	N/A	Clear Space?	N/A
	Road X Slope (%)	N/A	N/A	Clear Space to XWalk (in)	N/A
N/A	Any Obstructions?	N/A	N/A	Storm Grate/Utility Hazard?	N/A
	Obstruction Type			Storm Grate/Utility Type	
		N/A			N/A
		Yes		Surface Condition? (G/P)	Good

**Remove & Replace Entire Ramp.**

**Not Found, R304.2.2**

Total Cost: \$ 1850.00
