# Access Compliance Report

## Public Rights-of-Way

| Intersection ID: 14555 | Main Street: E_PARK_AV | Cross Street: PARK_RD | Location: W |
| ADA ID: 45A514DEAEDF | Ramp Type: BlendTrans1 | Initial Pass/Fail: Fail | Overall Compliance: No |

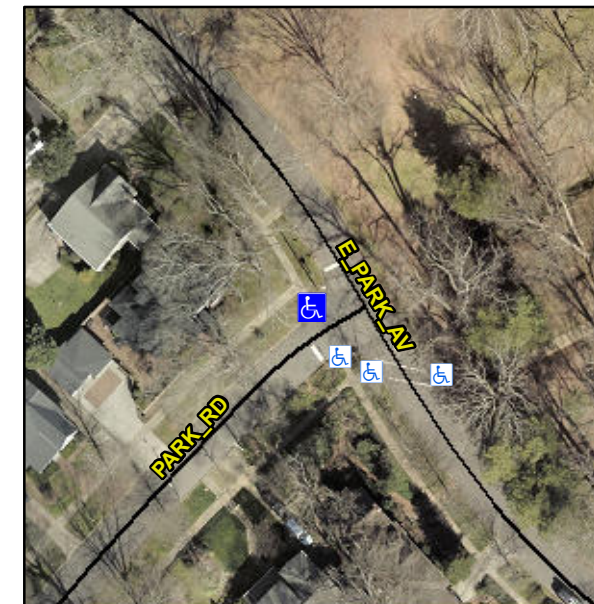
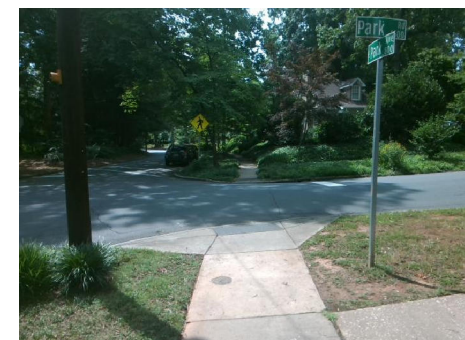
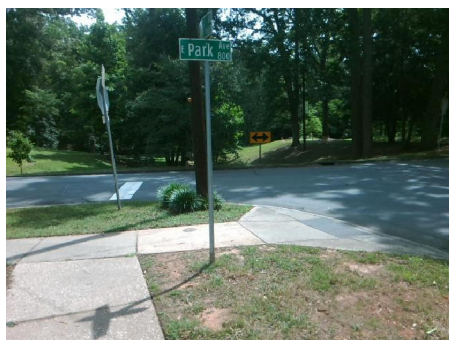
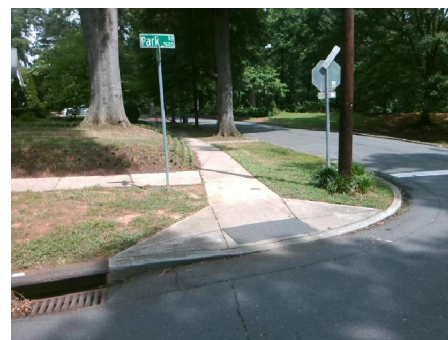
**Not Found, R304.5.3**

| Compliance | Description | Data | Compliance | Description | Data |
|---|---|---|---|---|---|
| Yes | Ramp Width (in) | 48.0 | No | BlendTrans XSlope (%) | 2.4 |
| | | | No | Curb Slope (%) | 10.7 |

**Remove & Replace Curb Ramp With Two New Directional Ramps or Equivalent.**

Total Cost: \$ 3200.00
