# Access Compliance Report

## Public Rights-of-Way

### (Curb Ramps)

| Intersection ID: 43360 | Main Street: HIGHLAND_COMMONS_RD | Cross Street: RIDGEVIEW_COMMONS_DR | Location: S |

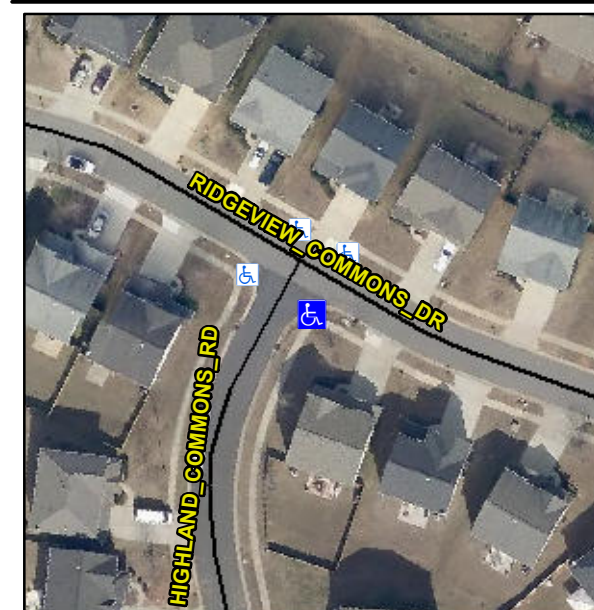
| ADA ID: 45A67CA432F5 | Ramp Type: PerpDiag | Initial Pass/Fail: Fail | Overall Compliance: No |
| Severity Score: 1.25 | | | |

**Not Found, R304.5.3**

| Compliance | Description | Data | Compliance | Description | Data |
|---|---|---|---|---|---|
| Yes | Ramp Width (in) | 48.0 | No | Ramp XSlope (%) | 3.8 |

**Remove & Replace Curb Ramp With Two New Directional Ramps or Equivalent.**

Total Cost: \$ 3200.00
