# Access Compliance Report

## Public Rights-of-Way

| Intersection ID: 47447 | Main Street: ACCIPITER_WY | Cross Street: CHRISTENBURY_RD | Location: W |
| ADA ID: 45C751EE5AF4 | Ramp Type: BlendTrans1 | Initial Pass/Fail: Fail | Overall Compliance: No |

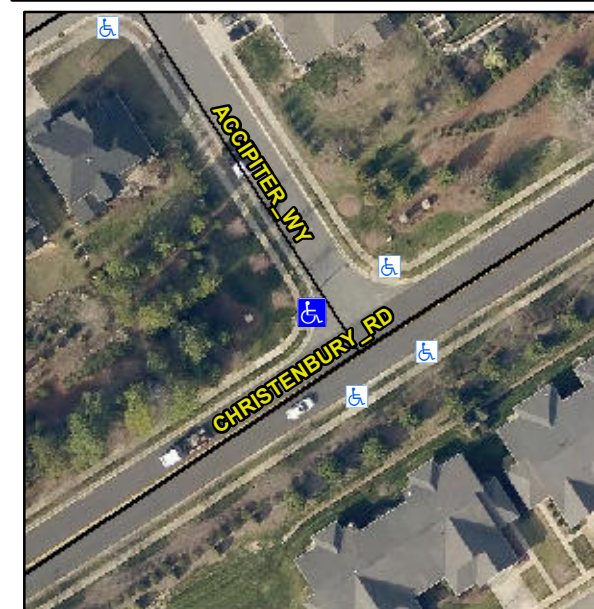
| Severity Score: 21.25 | | | |

**R304.5.1, R304.5.3**

| Compliance | Description | Data | Compliance | Description | Data |
|---|---|---|---|---|---|
| No | Ramp Width (in) | 39.5 | No | BlendTrans XSlope (%) | 5.9 |

**Remove & Replace Curb Ramp With Two New Directional Ramps or Equivalent.**

Total Cost: \$ 3200.00

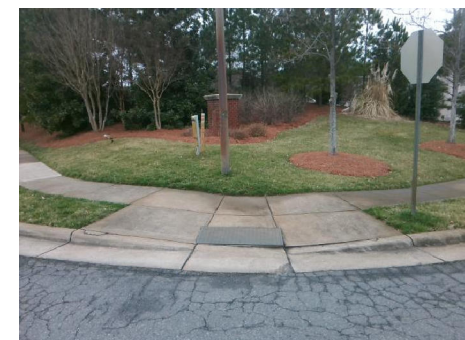
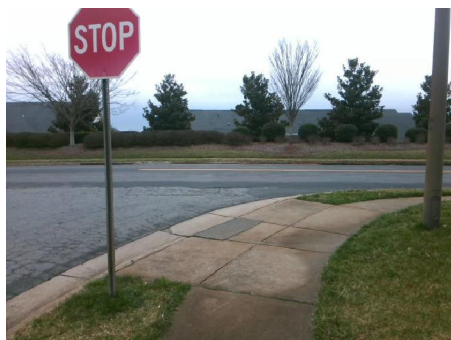
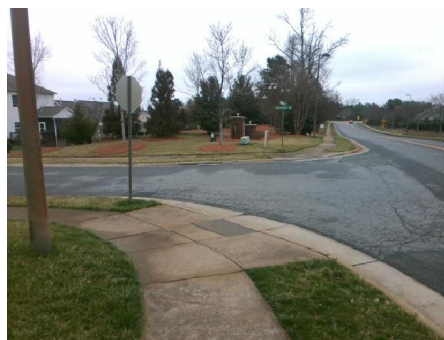
| Compliance | Description | Data | Compliance | Description | Data |
|---|---|---|---|---|---|
| N/A | Ramp Length (in) | 48.0 | Yes | BlendTrans Slope (%) | 4.4 |
