# Access Compliance Report

## Public Rights-of-Way

### (Curb Ramps)

| Intersection ID: 16168 | Main Street: CORONADO_DR | Cross Street: FARMINGDALE_DR | Location: W |

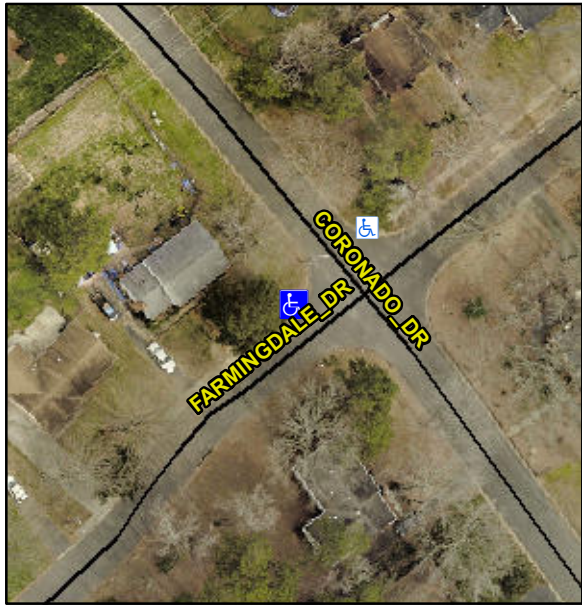
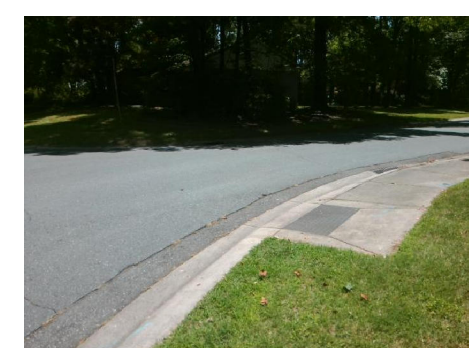
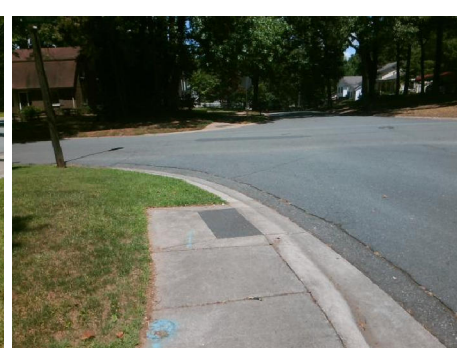
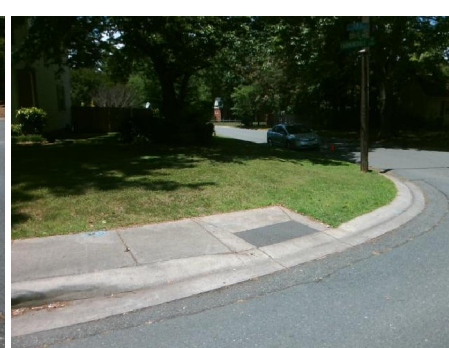
| ADA ID: 45C801D799CC | Ramp Type: PerpDiag | Initial Pass/Fail: Pass | Overall Compliance: No |

| Codes/Mitigation Info/Possible Solution | | | Field Measurements/Component Compliance | | | | | |
|---|---|---|---|---|---|---|---|---|
| | | | Yes | Ramp Width (in) | 48.0 | No | Ramp XSlope (%) | 4.3 |
| | | | No | Landing Length (in) | N/A | Yes | DWS Provided? | Yes |
| | | | No | Landing Width (in) | N/A | Yes | DWS Contrast? | Yes |
| | | | No | Landing Slope (%) | N/A | Yes | DWS Length (in) | 24.0 |
| | | | No | Landing X Slope (%) | N/A | Yes | DWS Full Width? | Yes |
| | | No | Gutter Lip Ht (in) | 0.5 | No | Gutter X Slope (%) | 3.3 | |

| Codes/Mitigation Info/Possible Solution | | | Field Measurements/Component Compliance | | | | | |
|---|---|---|---|---|---|---|---|---|
| | Remove & Replace Curb Ramp With Two New Directional Ramps or Equivalent. Remove & Replace Gutter. | | N/A | Ramp Length (in) | 54.0 | Yes | Ramp Slope (%) | 7.4 |
