# Access Compliance Report

## Public Rights-of-Way

### (Curb Ramps)

Intersection ID: 43118	Main Street: GRACE_ST	Cross Street: THE_PLAZA	Location: NW
ADA ID: 45D60F6D6F12	Ramp Type: Para	Initial Pass/Fail: Fail	Overall Compliance: No
Codes/Mitigation Info/Possible Solution		Field Measurements/Component Compliance	
Severity Score: 13.75

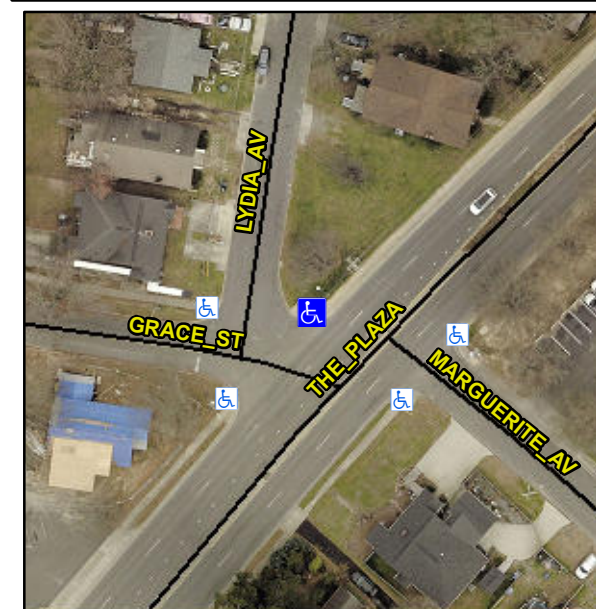
Compliance	Description	Data	Compliance	Description	Data
N/A	Ramp Length LT (in)	37.0	N/A	Ramp Length RT (in)	33.5
Yes	Ramp Width LT (in)	59.0	Yes	Ramp Width RT (in)	59.0
Yes	Ramp Slope LT (%)	6.8	No	Ramp Slope RT (%)	10.0
No	Ramp XSlope LT (%)	2.8	Yes	Ramp XSlope RT (%)	1.0
N/A	Landing Length (in)	N/A	N/A	DWS Provided?	N/A
N/A	Landing Width (in)	N/A	N/A	DWS Contrast?	N/A
N/A	Landing Slope (%)	N/A	N/A	DWS Length (in)	N/A
N/A	Landing X Slope (%)	N/A	N/A	DWS Full Width?	N/A
N/A	Landing Curb? (Y/N)	N/A	N/A	DWS Offset (in)	N/A
N/A	Shared Landing?	N/A			
N/A	Gutter Ponding?	N/A	N/A	Gutter Slope (%)	N/A
N/A	Gutter Lip Ht (in)	0.5	N/A	Gutter X Slope (%)	N/A
N/A	Painted X Walk1?	No	N/A	Painted X Walk2?	N/A
	X Walk 1 Direction	To SW		X Walk 2 Direction	N/A
N/A	X Walk 1 Width (in)	N/A	N/A	X Walk 2 Width (in)	N/A
	X Walk 1 Slope (%)	1.1		X Walk 2 Slope (%)	N/A
	X Walk 1 X Slope (%)	7.3		X Walk 2 X Slope (%)	N/A
N/A	Ramp inside XWalk1?	N/A	N/A	Ramp inside XWalk2?	N/A

Road Slope (%)	N/A	N/A	Clear Space?	N/A
	Road X Slope (%)	N/A	N/A	Clear Space to XWalk (in)	N/A
N/A	Any Obstructions?	N/A	N/A	Storm Grate/Utility Hazard?	N/A
	Obstruction Type			Storm Grate/Utility Type	
		N/A			N/A
			Yes	Surface Condition? (G/P)	Good
			N/A	Curb Slope (%)	4.5

**Remove & Replace Entire Ramp.**

**R304.5.3, R304.3.2**
