Access Compliance Report

Public Rights-of-Way

(Curb Ramps)

Intersection ID: 11316	Main Street: CAMP_GREENE_ST	Cross Street: ROYSTON_RD	Location: NW
ADA ID: 45D8B21D6F24	Ramp Type: Perp	Initial Pass/Fail: Fail	Overall Compliance: No
Codes/Mitigation Info/Possible Solution		Field Measurements/Component Compliance

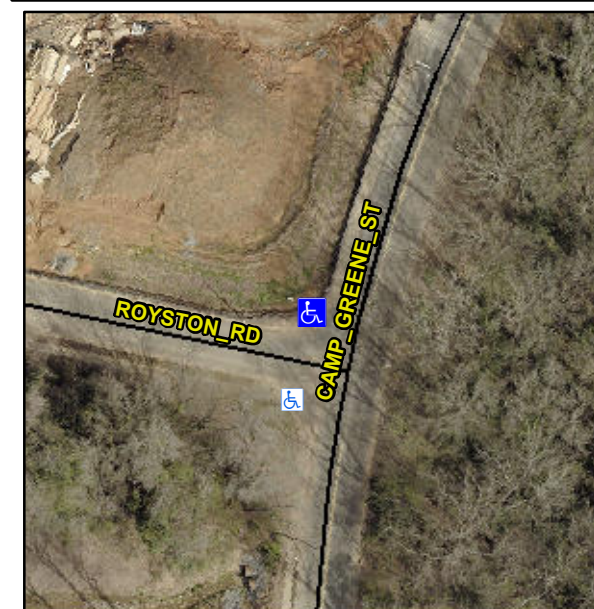
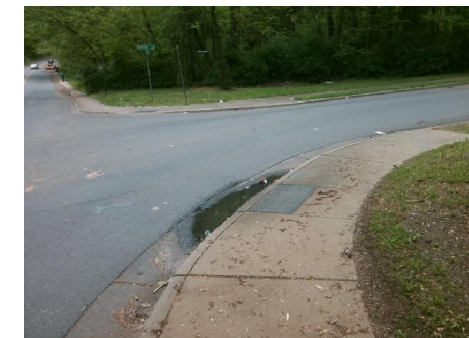
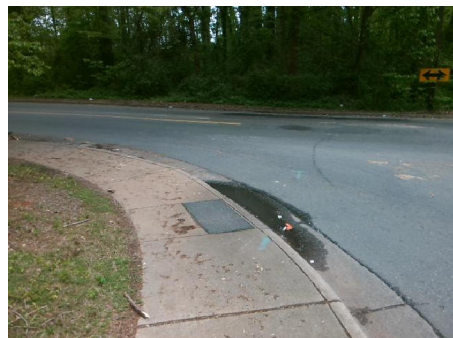
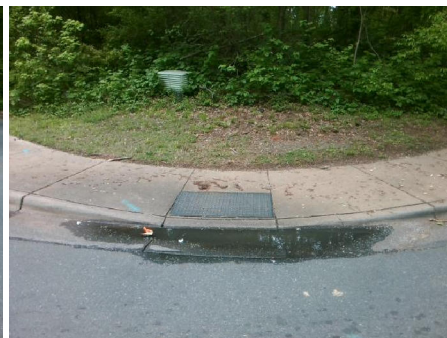
Not Found, R304.5.1, R304.2.2

Compliance	Description	Data	Compliance	Description	Data
N/A	Ramp Length (in)	60.0	No	Ramp Slope (%)	8.5
No	Ramp Width (in)	45.0	Yes	Ramp XSlope (%)	0.4
N/A	Flare Type LT	N/A	N/A	Flare Type RT	N/A
N/A	Flare Slope LT (%)	N/A	N/A	Flare Slope RT (%)	N/A
N/A	Flare Traversable LT?	N/A	N/A	Flare Traversable RT?	N/A
N/A	Landing Length (in)	N/A	N/A	DWS Provided?	N/A
N/A	Landing Width (in)	N/A	N/A	DWS Contrast?	N/A
N/A	Landing Slope (%)	N/A	N/A	DWS Length (in)	N/A
N/A	Landing X Slope (%)	N/A	N/A	DWS Full Width?	N/A
N/A	Landing Curb? (Y/N)	N/A	N/A	DWS Offset (in)	N/A
N/A	Shared Landing?	N/A			
N/A	Gutter Ponding?	Yes	N/A	Gutter Slope (%)	N/A
N/A	Gutter Lip Ht (in)	N/A	N/A	Gutter X Slope (%)	N/A
N/A	Painted X Walk1?	No	N/A	Painted X Walk2?	N/A
	X Walk 1 Direction	To S		X Walk 2 Direction	N/A
N/A	X Walk 1 Width (in)	N/A	N/A	X Walk 2 Width (in)	N/A
	X Walk 1 Slope (%)	0.4		X Walk 2 Slope (%)	N/A
	X Walk 1 X Slope (%)	1.7		X Walk 2 X Slope (%)	N/A

N/A	Ramp inside XWalk1?	N/A	N/A	Ramp inside XWalk2?	N/A
	Road Slope (%)	N/A	N/A	Clear Space?	N/A
	Road X Slope (%)	N/A	N/A	Clear Space to XWalk (in)	N/A
N/A	Any Obstructions?	N/A	N/A	Storm Grate/Utility Hazard?	N/A
	Obstruction Type			Storm Grate/Utility Type	
		N/A			N/A
			Yes	Surface Condition? (G/P)	Good

Remove & Replace Entire Ramp.

Total Cost: \$ 1850.00
