Access Compliance Report

Public Rights-of-Way

(Curb Ramps)

Intersection ID: 15689	Main Street: MCDONALD_AV	Cross Street: PARK_RD	Location: NW
ADA ID: 45DBEF0A987E	Ramp Type: Perp	Initial Pass/Fail: Fail	Overall Compliance: No
		Severity Score: 8.75

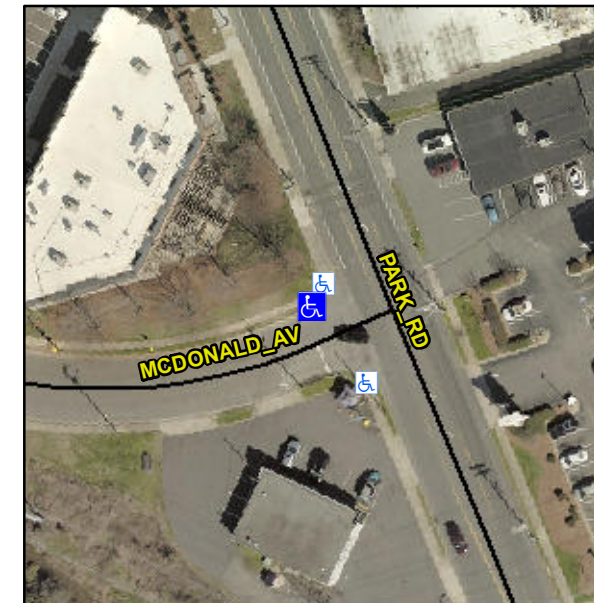
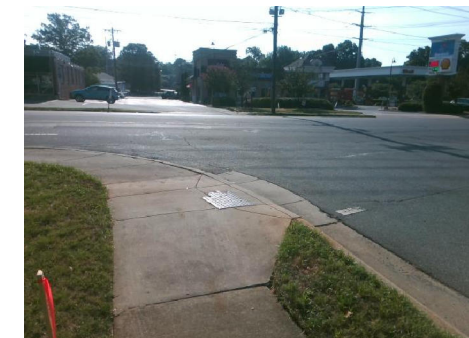
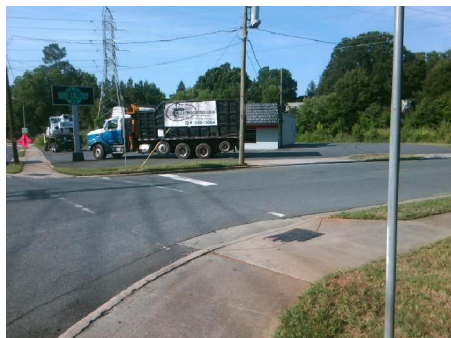
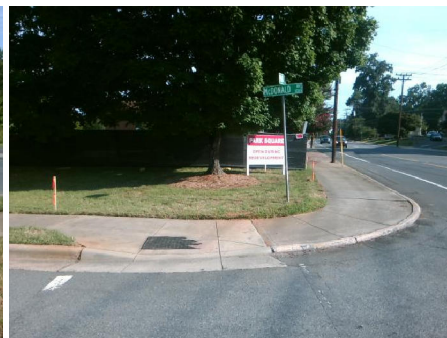
Not Found, R304.5.1

Compliance	Description	Data	Compliance	Description	Data
N/A	Ramp Length (in)	24.0	Yes	Ramp Slope (%)	5.1
No	Ramp Width (in)	47.0	Yes	Ramp XSlope (%)	0.4
N/A	Flare Type LT	N/A	N/A	Flare Type RT	N/A
N/A	Flare Slope LT (%)	N/A	N/A	Flare Slope RT (%)	N/A
N/A	Flare Traversable LT?	N/A	N/A	Flare Traversable RT?	N/A
N/A	Landing Length (in)	N/A	N/A	DWS Provided?	N/A
N/A	Landing Width (in)	N/A	N/A	DWS Contrast?	N/A
N/A	Landing Slope (%)	N/A	N/A	DWS Length (in)	N/A
N/A	Landing X Slope (%)	N/A	N/A	DWS Full Width?	N/A
N/A	Landing Curb? (Y/N)	N/A	N/A	DWS Offset (in)	N/A
N/A	Shared Landing?	N/A			
N/A	Gutter Ponding?	N/A	N/A	Gutter Slope (%)	N/A
N/A	Gutter Lip Ht (in)	1.0	N/A	Gutter X Slope (%)	N/A
N/A	Painted X Walk1?	No	N/A	Painted X Walk2?	N/A
	X Walk 1 Direction	To SE		X Walk 2 Direction	N/A
N/A	X Walk 1 Width (in)	N/A	N/A	X Walk 2 Width (in)	N/A
	X Walk 1 Slope (%)	2.3		X Walk 2 Slope (%)	N/A
	X Walk 1 X Slope (%)	2.8		X Walk 2 X Slope (%)	N/A

N/A	Ramp inside XWalk1?	N/A	N/A	Ramp inside XWalk2?	N/A
	Road Slope (%)	N/A	N/A	Clear Space?	N/A
	Road X Slope (%)	N/A	N/A	Clear Space to XWalk (in)	N/A
N/A	Any Obstructions?	N/A	N/A	Storm Grate/Utility Hazard?	N/A
	Obstruction Type			Storm Grate/Utility Type	
		N/A			N/A
			Yes	Surface Condition? (G/P)	Good

Possible Solutions:

Remove & Replace Entire Ramp.
