Access Compliance Report

Public Rights-of-Way

(Curb Ramps)

Intersection ID: 51511	Main Street: PEARL_PARK_WY	Cross Street: S_KINGS_DR	Location: NE
ADA ID: 45DE779C96C9	Ramp Type: Perp	Initial Pass/Fail: Fail	Overall Compliance: No
Severity Score: 12.5			
Codes/Mitigation Info/Possible Solution		Field Measurements/Component Compliance

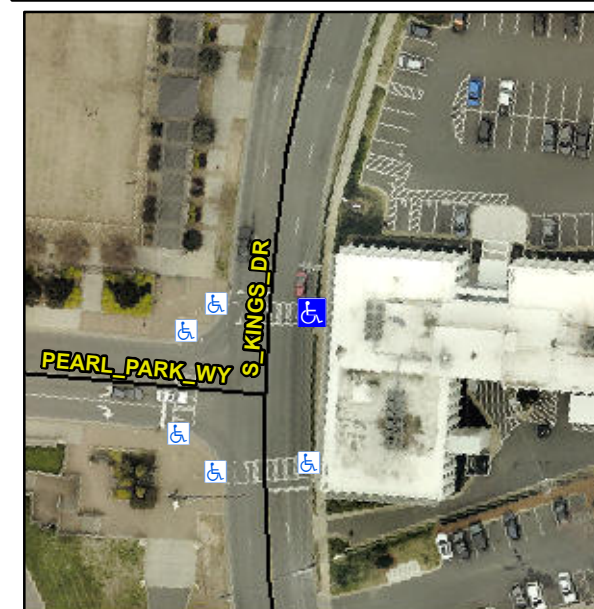
Not Found, R304.2.2

Compliance	Description	Data	Compliance	Description	Data
N/A	Ramp Length (in)	85.0	No	Ramp Slope (%)	8.9
Yes	Ramp Width (in)	48.0	Yes	Ramp XSlope (%)	1.0
N/A	Flare Type LT	N/A	N/A	Flare Type RT	N/A
N/A	Flare Slope LT (%)	N/A	N/A	Flare Slope RT (%)	N/A
N/A	Flare Traversable LT?	N/A	N/A	Flare Traversable RT?	N/A
N/A	Landing Length (in)	N/A	N/A	DWS Provided?	N/A
N/A	Landing Width (in)	N/A	N/A	DWS Contrast?	N/A
N/A	Landing Slope (%)	N/A	N/A	DWS Length (in)	N/A
N/A	Landing X Slope (%)	N/A	N/A	DWS Full Width?	N/A
N/A	Landing Curb? (Y/N)	N/A	N/A	DWS Offset (in)	N/A
N/A	Shared Landing?	N/A			
N/A	Gutter Ponding?	N/A	N/A	Gutter Slope (%)	N/A
N/A	Gutter Lip Ht (in)	N/A	N/A	Gutter X Slope (%)	N/A
N/A	Painted X Walk1?	Yes	N/A	Painted X Walk2?	N/A
	X Walk 1 Direction	To W		X Walk 2 Direction	N/A
N/A	X Walk 1 Width (in)	120.0	N/A	X Walk 2 Width (in)	N/A
	X Walk 1 Slope (%)	5.5		X Walk 2 Slope (%)	N/A
	X Walk 1 X Slope (%)	1.7		X Walk 2 X Slope (%)	N/A

N/A	Ramp inside XWalk1?	Yes	N/A	Ramp inside XWalk2?	N/A
	Road Slope (%)	N/A	N/A	Clear Space?	N/A
	Road X Slope (%)	N/A	N/A	Clear Space to XWalk (in)	N/A
N/A	Any Obstructions?	N/A	N/A	Storm Grate/Utility Hazard?	N/A
	Obstruction Type			Storm Grate/Utility Type	
		N/A			N/A
		Yes		Surface Condition? (G/P)	Good

Possible Solutions:

Remove & Replace Entire Ramp.
