Access Compliance Report Public Rights-of-Way (Curb Ramps)

Intersection ID: 48133 Main Street: WHISTLER'S_CHASE_DR				eet:	ACORN_CREEK_LN	Location:	SW			
ADA ID: 45EAC6171CDB Ramp Type: PerpDiag			nitial Pass/Fail: Fail Overall Compliance: No				Severity Score:	10		
Codes/Mitigation Info/Possible Solution				Field Measurements/Component Compliance						
	C to	Possible Solutions:	C	Compliance Description			Data Compliance Description		Data	
A 11 A		Remove & Replace Curb Ramp W	ith N	I/A	Ramp Length (in)	47.5	Yes	Ramp Slope (%)	6.6	
		Two New Directional Ramps or		lo	Ramp Width (in)	43.0	No	Ramp XSlope (%)	2.2	
		Equivalent.	N	/ A	Flare Type LT	N/A	N/A	Flare Type RT	N/A	
			Ν	I/A	Flare Slope LT (%)	N/A	N/A	Flare Slope RT (%)	N/A	
	and the second s		N	I/A	Flare Traversable LT?	N/A	N/A	Flare Traversable RT?	N/A	
Surveyor Notes: N/A PROW/ADA: Not Found, R304.5.1, R304.			Ν	I/A	Landing Length (in)	N/A	N/A	DWS Provided?	N/A	
		Surveyor Notes:	Ν	I/A	Landing Width (in)	N/A	N/A	DWS Contrast?	N/A

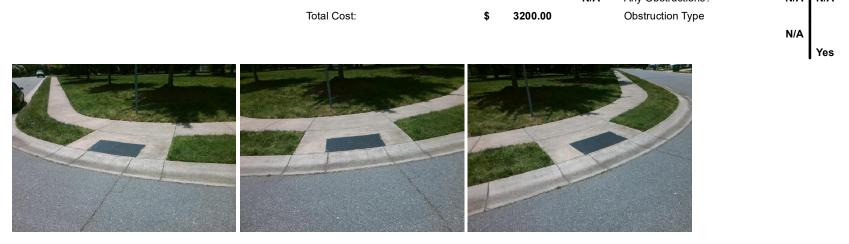
N/A	Ν	I/A	Landing Slope (%)	N/A	N/A	DWS Length (in)	N/A	
			N	I/A	Landing X Slope (%)	N/A	N/A	DWS Full Width?	N/A	
			Ν	I/A	Landing Curb? (Y/N)	N/A	N/A	DWS Offset (in)	N/A	
			Ν	I/A	Shared Landing?	N/A				
		PROW/ADA:		I/A	Gutter Ponding?	N/A	N/A	Gutter Slope (%)	N/A	
		Not Found R304 5 1 R304 5 3	Ν	/ A	Gutter Lip Ht (in)	N/A	N/A	Gutter X Slope (%)	N/A	
			N	I/A	Painted X Walk1?	No	N/A	Painted X Walk2?	No	
					X Walk 1 Direction	To E		X Walk 2 Direction	To N	
			N	I/A	X Walk 1 Width (in)	N/A	N/A	X Walk 2 Width (in)	N/A	
Street 1 Name WHISTL	LER'S CHASE DR	-			X Walk 1 Slope (%)	2.5		X Walk 2 Slope (%)	5.0	
Stop Condition-Street 2	StopSign				X Walk 1 X Slope (%)	4.7		X Walk 2 X Slope (%)	0.2	
Street 2 Name AC	CORN CREEK LN		N	I/A	Ramp inside XWalk1?	N/A	N/A	Ramp inside XWalk2?	N/A	
Stop Condition-Street 1	None				Road Slope (%)	3.4	N/A	Clear Space?	N/A	
					Road X Slope (%)	3.6	N/A	Clear Space to XWalk (in)	N/A

Ν	I/A	Any Obstructions?	N/A	N/A	Storm Grate/Utility Hazard?	N/A	
		Total Cost: \$ 32	00.00		Obstruction Type			Storm Grate/Utility Type		
						N/A			N/A
