Access Compliance Report Public Rights-of-Way (Curb Ramps)

Intersection ID: 47164 Main Street: SOUTH PARK DR **Cross Street: FAIRVIEW RD** Location: S **Overall Compliance: No Severity Score:** 22.5 ADA ID: 45EF2D400ACB Ramp Type: MedianPerp Initial Pass/Fail: Fail

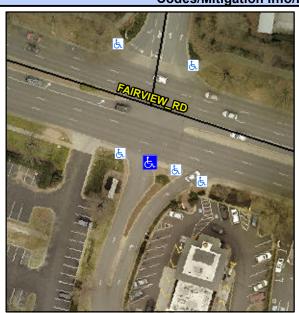
Compliance Description <u>Data</u> Compliance Description Data No N/A Ramp Length (in) 65.0 Ramp Slope (%) 9.6 No Ramp XSlope (%) No Ramp Width (in) 46.0 2.7 N/A N/A Flare Type LT N/A Flare Type RT N/A N/A Flare Slope LT (%) N/A N/A Flare Slope RT (%) N/A N/A Flare Traversable LT? N/A N/A Flare Traversable RT? N/A N/A N/A N/A **DWS Provided?** N/A Landing Length (in) N/A Landing Width (in) N/A N/A **DWS Contrast?** N/A N/A N/A N/A Landing Slope (%) DWS Length (in) N/A N/A Landing X Slope (%) N/A N/A DWS Full Width? N/A N/A Landing Curb? (Y/N) N/A N/A DWS Offset (in) N/A N/A N/A Shared Landing? N/A **Gutter Ponding?** N/A N/A Gutter Slope (%) N/A N/A Gutter Lip Ht (in) N/A N/A Gutter X Slope (%) N/A N/A Painted X Walk1? No N/A Painted X Walk2? N/A X Walk 1 Direction To W X Walk 2 Direction N/A N/A N/A X Walk 2 Width (in) X Walk 1 Width (in) N/A X Walk 1 Slope (%) 0.8 X Walk 2 Slope (%) N/A X Walk 2 X Slope (%) X Walk 1 X Slope (%) 1.4 N/A N/A N/A N/A Ramp inside XWalk2? Ramp inside XWalk1? N/A Road Slope (%) N/A N/A Clear Space? N/A Road X Slope (%) N/A N/A Clear Space to XWalk (in) N/A N/A N/A Any Obstructions? N/A Storm Grate/Utility Hazard? N/A **Obstruction Type** Storm Grate/Utility Type N/A N/A

Possible Solutions:				
Remove & Replace Entire Ramp.				
•				
Surveyor Notes:				
N/A				
PROW/ADA:				
Not Found, R304.5.1, R304.2.2, R304.5.3
