Access Compliance Report

Public Rights-of-Way

(Curb Ramps)

Intersection ID: 22240	Main Street: CARMEL_RD	Cross Street: MILL_POND_RD	Location: NE
ADA ID: 460BA7F746F9	Ramp Type: PerpDiag	Initial Pass/Fail: Fail	Overall Compliance: No
		Severity Score: 22.5

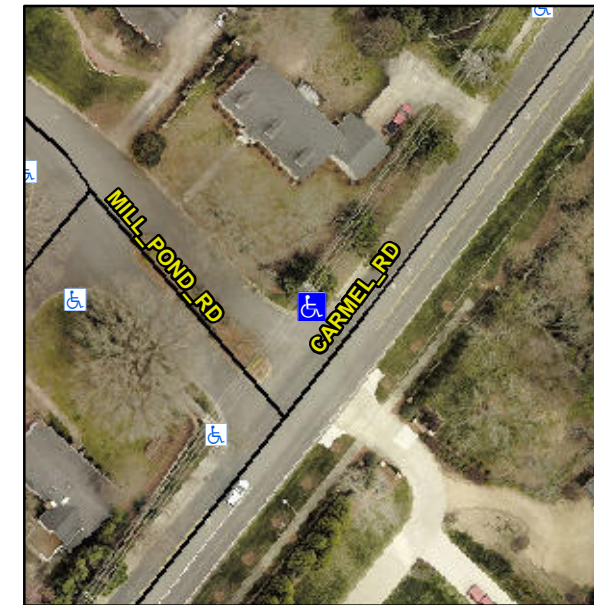
Not Found, R304.5.1, R304.2.2, R304.5.3

Compliance	Description	Data	Compliance	Description	Data
N/A	Ramp Length (in)	35.0	No	Ramp Slope (%)	9.1
No	Ramp Width (in)	40.0	No	Ramp XSlope (%)	3.9
N/A	Flare Type LT	N/A	N/A	Flare Type RT	N/A
N/A	Flare Slope LT (%)	N/A	N/A	Flare Slope RT (%)	N/A
N/A	Flare Traversable LT?	N/A	N/A	Flare Traversable RT?	N/A
N/A	Landing Length (in)	N/A	N/A	DWS Provided?	N/A
N/A	Landing Width (in)	N/A	N/A	DWS Contrast?	N/A
N/A	Landing Slope (%)	N/A	N/A	DWS Length (in)	N/A
N/A	Landing X Slope (%)	N/A	N/A	DWS Full Width?	N/A
N/A	Landing Curb? (Y/N)	N/A	N/A	DWS Offset (in)	N/A
N/A	Shared Landing?	N/A			
N/A	Gutter Ponding?	N/A	N/A	Gutter Slope (%)	N/A
N/A	Gutter Lip Ht (in)	N/A	N/A	Gutter X Slope (%)	N/A
N/A	Painted X Walk1?	No	N/A	Painted X Walk2?	No
	X Walk 1 Direction	To SW		X Walk 2 Direction	To SE
N/A	X Walk 1 Width (in)	N/A	N/A	X Walk 2 Width (in)	N/A
	X Walk 1 Slope (%)	2.0		X Walk 2 Slope (%)	8.7
	X Walk 1 X Slope (%)	3.9		X Walk 2 X Slope (%)	1.1

N/A	Ramp inside XWalk1?	N/A	N/A	Ramp inside XWalk2?	N/A
	Road Slope (%)	0.0	N/A	Clear Space?	N/A
	Road X Slope (%)	2.2	N/A	Clear Space to XWalk (in)	N/A
N/A	Any Obstructions?	N/A	N/A	Storm Grate/Utility Hazard?	N/A
	Obstruction Type			Storm Grate/Utility Type	
		N/A			N/A
			Yes	Surface Condition? (G/P)	Good

Possible Solutions:

Remove & Replace Curb Ramp With Two New Directional Ramps or Equivalent.
