Access Compliance Report

Public Rights-of-Way

(Curb Ramps)

Intersection ID: 23951	Main Street: S_TRYON_ST	Cross Street: CHOATE_CR	Location: SE
ADA ID: 461051FA6481	Ramp Type: Perp	Initial Pass/Fail: Fail	Overall Compliance: No
Severity Score: 12.5			
Codes/Mitigation Info/Possible Solution		Field Measurements/Component Compliance

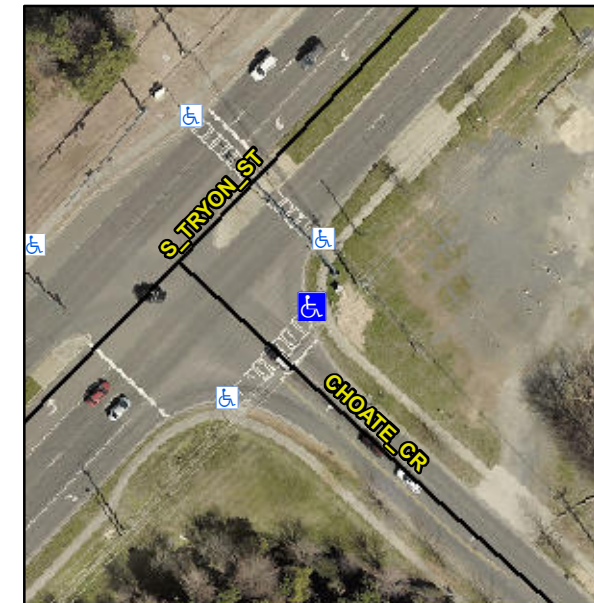
Not Found, R304.2.2

Compliance	Description	Data	Compliance	Description	Data
N/A	Ramp Length (in)	120.0	No	Ramp Slope (%)	9.0
Yes	Ramp Width (in)	48.0	Yes	Ramp XSlope (%)	0.6
N/A	Flare Type LT	N/A	N/A	Flare Type RT	N/A
N/A	Flare Slope LT (%)	N/A	N/A	Flare Slope RT (%)	N/A
N/A	Flare Traversable LT?	N/A	N/A	Flare Traversable RT?	N/A
N/A	Landing Length (in)	N/A	N/A	DWS Provided?	N/A
N/A	Landing Width (in)	N/A	N/A	DWS Contrast?	N/A
N/A	Landing Slope (%)	N/A	N/A	DWS Length (in)	N/A
N/A	Landing X Slope (%)	N/A	N/A	DWS Full Width?	N/A
N/A	Landing Curb? (Y/N)	N/A	N/A	DWS Offset (in)	N/A
N/A	Shared Landing?	N/A			
N/A	Gutter Ponding?	N/A	N/A	Gutter Slope (%)	N/A
N/A	Gutter Lip Ht (in)	N/A	N/A	Gutter X Slope (%)	N/A
N/A	Painted X Walk1?	Yes	N/A	Painted X Walk2?	N/A
	X Walk 1 Direction	To SW		X Walk 2 Direction	N/A
N/A	X Walk 1 Width (in)	114.0	N/A	X Walk 2 Width (in)	N/A
	X Walk 1 Slope (%)	3.0		X Walk 2 Slope (%)	N/A
	X Walk 1 X Slope (%)	3.1		X Walk 2 X Slope (%)	N/A

N/A	Ramp inside XWalk1?	Yes	N/A	Ramp inside XWalk2?	N/A
	Road Slope (%)	N/A	N/A	Clear Space?	N/A
	Road X Slope (%)	N/A	N/A	Clear Space to XWalk (in)	N/A
N/A	Any Obstructions?	N/A	N/A	Storm Grate/Utility Hazard?	N/A
	Obstruction Type			Storm Grate/Utility Type	
		N/A			N/A
			Yes	Surface Condition? (G/P)	Good

Possible Solutions:

Remove & Replace Entire Ramp.
