# Access Compliance Report

## Public Rights-of-Way

### (Curb Ramps)

Intersection ID: 8671	Main Street: BRADFORD_DR	Cross Street: SARATOGA_DR	Location: S
ADA ID: 46209B661A1A	Ramp Type: Perp	Initial Pass/Fail: Fail	Overall Compliance: No
Severity Score: 8.75			
Codes/Mitigation Info/Possible Solution		Field Measurements/Component Compliance

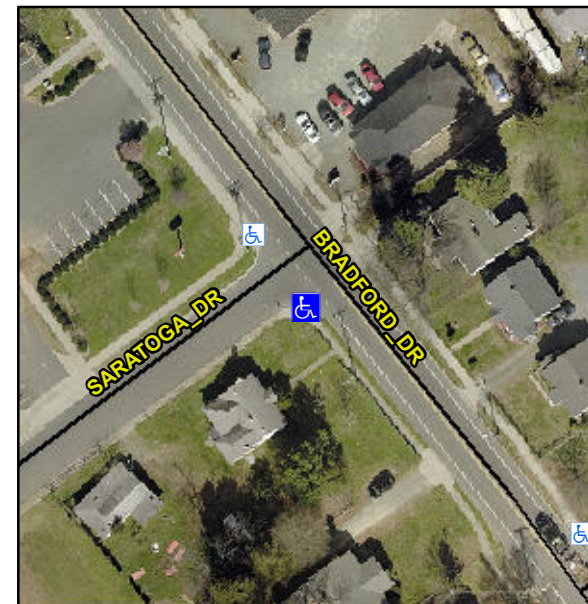
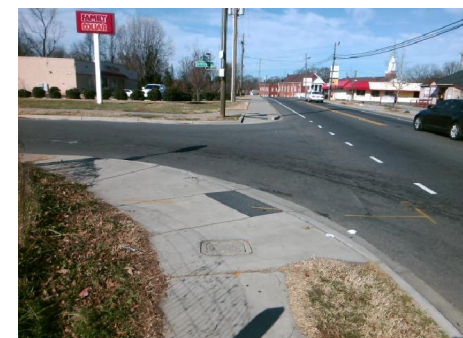
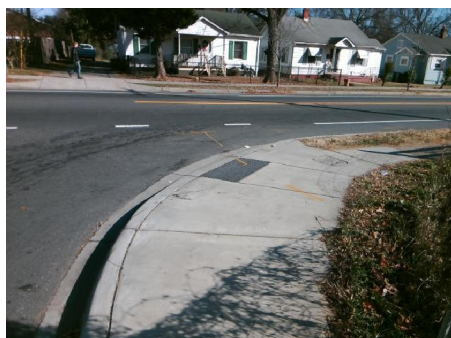
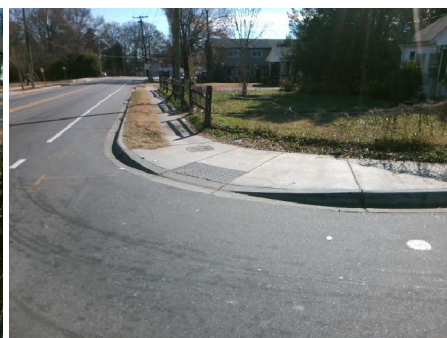
**Not Found, R304.5.1**

Compliance	Description	Data	Compliance	Description	Data
N/A	Ramp Length (in)	80.0	Yes	Ramp Slope (%)	5.3
No	Ramp Width (in)	41.0	Yes	Ramp XSlope (%)	0.9
N/A	Flare Type LT	N/A	N/A	Flare Type RT	N/A
N/A	Flare Slope LT (%)	N/A	N/A	Flare Slope RT (%)	N/A
N/A	Flare Traversable LT?	N/A	N/A	Flare Traversable RT?	N/A
N/A	Landing Length (in)	N/A	N/A	DWS Provided?	N/A
N/A	Landing Width (in)	N/A	N/A	DWS Contrast?	N/A
N/A	Landing Slope (%)	N/A	N/A	DWS Length (in)	N/A
N/A	Landing X Slope (%)	N/A	N/A	DWS Full Width?	N/A
N/A	Landing Curb? (Y/N)	N/A	N/A	DWS Offset (in)	N/A
N/A	Shared Landing?	N/A			
N/A	Gutter Ponding?	N/A	N/A	Gutter Slope (%)	N/A
N/A	Gutter Lip Ht (in)	N/A	N/A	Gutter X Slope (%)	N/A
N/A	Painted X Walk1?	No	N/A	Painted X Walk2?	N/A
	X Walk 1 Direction	To NW		X Walk 2 Direction	N/A
N/A	X Walk 1 Width (in)	N/A	N/A	X Walk 2 Width (in)	N/A
	X Walk 1 Slope (%)	2.6		X Walk 2 Slope (%)	N/A
	X Walk 1 X Slope (%)	0.5		X Walk 2 X Slope (%)	N/A

N/A	Ramp inside XWalk1?	N/A	N/A	Ramp inside XWalk2?	N/A
	Road Slope (%)	N/A	N/A	Clear Space?	N/A
	Road X Slope (%)	N/A	N/A	Clear Space to XWalk (in)	N/A
N/A	Any Obstructions?	N/A	N/A	Storm Grate/Utility Hazard?	N/A
	Obstruction Type			Storm Grate/Utility Type	
		N/A			N/A
			Yes	Surface Condition? (G/P)	Good

Possible Solutions:

**Remove & Replace Entire Ramp.**

Total Cost: \$ 1850.00
