Access Compliance Report

Public Rights-of-Way

(Curb Ramps)

Intersection ID: 12760	Main Street: N_MYERS_ST	Cross Street: E_7TH_ST	Location: S
ADA ID: 4622F3D12605	Ramp Type: PerpDiag	Initial Pass/Fail: Fail	Overall Compliance: No
		Severity Score: 25

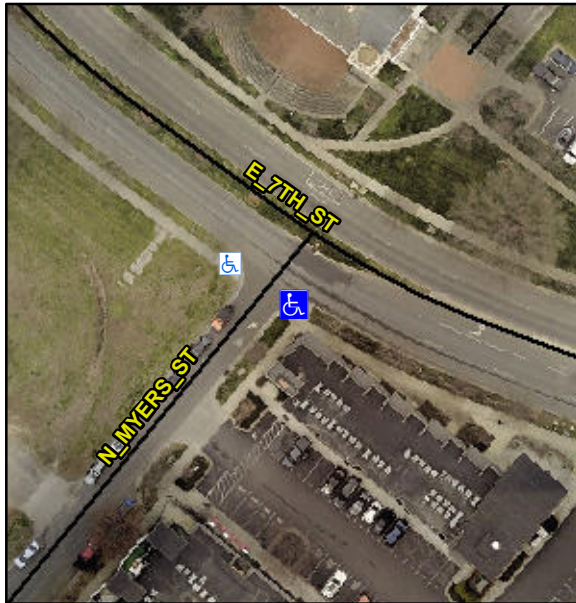
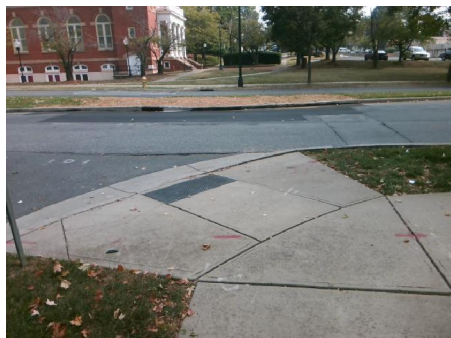
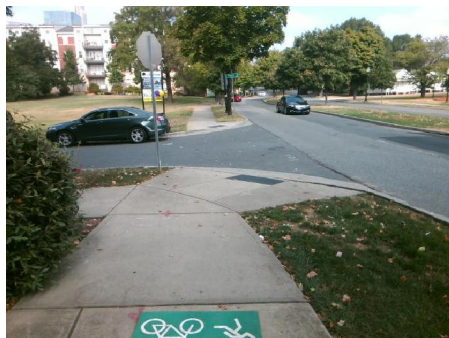
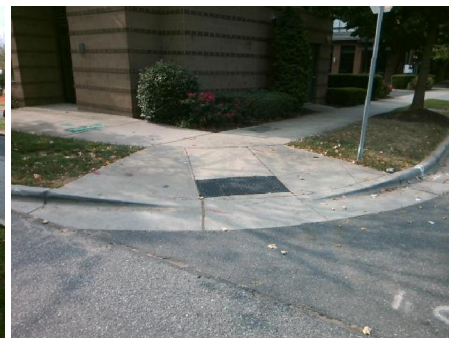
Not Found, R304.5.1, R304.5.3, R302.7

Compliance	Description	Data	Compliance	Description	Data
N/A	Ramp Length (in)	94.0	Yes	Ramp Slope (%)	5.7
No	Ramp Width (in)	47.0	No	Ramp XSlope (%)	2.1
N/A	Flare Type LT	N/A	N/A	Flare Type RT	N/A
N/A	Flare Slope LT (%)	N/A	N/A	Flare Slope RT (%)	N/A
N/A	Flare Traversable LT?	N/A	N/A	Flare Traversable RT?	N/A
N/A	Landing Length (in)	N/A	N/A	DWS Provided?	N/A
N/A	Landing Width (in)	N/A	N/A	DWS Contrast?	N/A
N/A	Landing Slope (%)	N/A	N/A	DWS Length (in)	N/A
N/A	Landing X Slope (%)	N/A	N/A	DWS Full Width?	N/A
N/A	Landing Curb? (Y/N)	N/A	N/A	DWS Offset (in)	N/A
N/A	Shared Landing?	N/A			
N/A	Gutter Ponding?	N/A	N/A	Gutter Slope (%)	N/A
N/A	Gutter Lip Ht (in)	N/A	N/A	Gutter X Slope (%)	N/A
N/A	Painted X Walk1?	No	N/A	Painted X Walk2?	No
	X Walk 1 Direction	To NE		X Walk 2 Direction	To NW
N/A	X Walk 1 Width (in)	N/A	N/A	X Walk 2 Width (in)	N/A
	X Walk 1 Slope (%)	0.9		X Walk 2 Slope (%)	5.1
	X Walk 1 X Slope (%)	1.9		X Walk 2 X Slope (%)	3.4

N/A	Ramp inside XWalk1?	N/A	N/A	Ramp inside XWalk2?	N/A
	Road Slope (%)	2.1	N/A	Clear Space?	N/A
	Road X Slope (%)	4.8	N/A	Clear Space to XWalk (in)	N/A
N/A	Any Obstructions?	N/A	N/A	Storm Grate/Utility Hazard?	N/A
	Obstruction Type			Storm Grate/Utility Type	
		N/A			N/A
		No		Surface Condition? (G/P)	Poor

Remove & Replace Curb Ramp With Two New Directional Ramps or Equivalent.
