## Access Compliance Report Public Rights-of-Way (Curb Ramps)

Intersection ID: 20485Main Street:FAIRVIEW\_RDCross Street:ASHLEY\_PARK\_LNLocation:SWADA ID: 46250E73D31FRamp Type:PerpDiagInitial Pass/Fail:FailOverall Compliance:NoSeverity Score:21.25

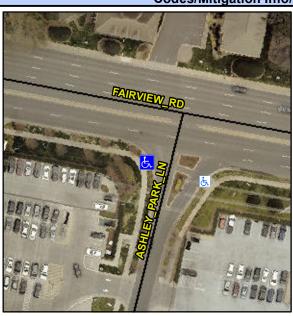
Field Measurements/Component Compliance						
	Compliance Description		Data	Compliance Description		Data
	N/A	Ramp Length (in)	72.0	No	Ramp Slope (%)	8.4
	No	Ramp Width (in)	47.0	Yes	Ramp XSlope (%)	1.8
	N/A	Flare Type LT	N/A	N/A	Flare Type RT	N/A
	N/A	Flare Slope LT (%)	N/A	N/A	Flare Slope RT (%)	N/A
	N/A	Flare Traversable LT?	N/A	N/A	Flare Traversable RT?	N/A
	N/A	Landing Length (in)	N/A	N/A	DWS Provided?	N/A
	N/A	Landing Width (in)	N/A	N/A	DWS Contrast?	N/A
	N/A	Landing Slope (%)	N/A	N/A	DWS Length (in)	N/A
	N/A	Landing X Slope (%)	N/A	N/A	DWS Full Width?	N/A
	N/A	Landing Curb? (Y/N)	N/A	N/A	DWS Offset (in)	N/A
	N/A	Shared Landing?	N/A			
	N/A	Gutter Ponding?	N/A	N/A	Gutter Slope (%)	N/A
	N/A	Gutter Lip Ht (in)	N/A	N/A	Gutter X Slope (%)	N/A
	N/A	Painted X Walk1?	No	N/A	Painted X Walk2?	No
		X Walk 1 Direction	To SE		X Walk 2 Direction	To NE
	N/A	X Walk 1 Width (in)	N/A	N/A	X Walk 2 Width (in)	N/A
		X Walk 1 Slope (%)	1.9		X Walk 2 Slope (%)	1.4

X Walk 1 X Slope (%)	0.8		X Walk 2 X Slope (%)	1.2
	N/A	Ramp inside XWalk1?	N/A	N/A	Ramp inside XWalk2?	N/A
		Road Slope (%)	2.1	N/A	Clear Space?	N/A
		Road X Slope (%)	2.4	N/A	Clear Space to XWalk (in)	N/A
	N/A	Any Obstructions?	N/A	N/A	Storm Grate/Utility Hazard?	N/A
		Obstruction Type			Storm Grate/Utility Type	
			N/A			N/A
				Yes	Surface Condition? (G/P)	Good
	A STATE OF THE PARTY OF THE PAR

Remove & Replace Curb Ramp With
Two New Directional Ramps or
Equivalent.

R304.5.1, R304.2.2
