Access Compliance Report Public Rights-of-Way (Curb Ramps)

<u> </u>	<u> </u>	,						
Intersection ID: 30210	0 Main Street: HIDDEN_CREEK_DR				Cross Street: N/A				NW	
ADA ID: 462E0F5DAB36	Ramp Ty	Ramp Type: PerpDiag			ail: Fail Overall C	o Severity Score:	10			
Codes/Mitigation Info/Possible Solution					Field Measurements/Component Compliance					
	(AB)	Possible Solutions:		Compliance Description		Data	Data Compliance Description			
		Remove & Replace Curb Ramp	With	N/A	Ramp Length (in)	47.5	Yes	Ramp Slope (%)	8.2	
		Two New Directional Ramps or Equivalent.		No	Ramp Width (in)	44.0	No	Ramp XSlope (%)	4.4	
				N/A	Flare Type LT	N/A	N/A	Flare Type RT	N/A	
				N/A	Flare Slope LT (%)	N/A	N/A	Flare Slope RT (%)	N/A	
	222 4			N/A	Flare Traversable LT?	N/A	N/A	Flare Traversable RT?	N/A	
2				N/A	Landing Length (in)	N/A	N/A	DWS Provided?	N/A	
		Surveyor Notes:		N/A	Landing Width (in)	N/A	N/A	DWS Contrast?	N/A	
		N/A		N/A	Landing Slope (%)	N/A	N/A	DWS Length (in)	N/A

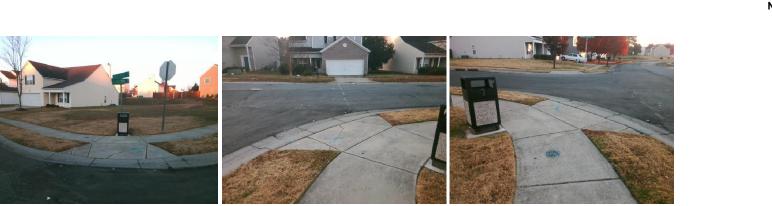
A GITTE	6. A			N/A	Landing X Slope (%)	N/A	N/A	DWS Full Width?	N/A	
and the second s				N/A	Landing Curb? (Y/N)	N/A	N/A	DWS Offset (in)	N/A	
File	COR BANA.			N/A	Shared Landing?	N/A				
Mar 1 - al	SP P T	PROW/ADA:		N/A	Gutter Ponding?	N/A	N/A	Gutter Slope (%)	N/A	
A ALANDA	A. P	Not Found, R304.5.1, R304.5.3		N/A	Gutter Lip Ht (in)	N/A	N/A	Gutter X Slope (%)	N/A	
				N/A	Painted X Walk1?	No	N/A	Painted X Walk2?	No	
					X Walk 1 Direction	To S		X Walk 2 Direction	To E	
				N/A	X Walk 1 Width (in)	N/A	N/A	X Walk 2 Width (in)	N/A	
Street 1 Name	HIDDEN CREEK DR				X Walk 1 Slope (%)	0.1		X Walk 2 Slope (%)	4.2	
Stop Condition-Street 2	None				X Walk 1 X Slope (%)	2.1		X Walk 2 X Slope (%)	3.3	
Street 2 Name	HIDDEN CREEK DR			N/A	Ramp inside XWalk1?	N/A	N/A	Ramp inside XWalk2?	N/A	
Stop Condition-Street 1	StopSign				Road Slope (%)	0.0	N/A	Clear Space?	N/A	
					Road X Slope (%)	4.0	N/A	Clear Space to XWalk (in)	N/A

N/A	Any Obstructions?	N/A	N/A	Storm Grate/Utility Hazard?	N/A	
		Total Cost: \$	3200.00		Obstruction Type			Storm Grate/Utility Type		
						N/A			N/A
