Access Compliance Report

Public Rights-of-Way

(Curb Ramps)

Intersection ID: 46733	Main Street: DARCY_HOPKINS_DR	Cross Street: BEAVER_BROOK_WY	Location: SW
ADA ID: 463180A1ADD0	Ramp Type: PerpDiag	Initial Pass/Fail: Fail	Overall Compliance: No
Severity Score: 10			
Codes/Mitigation Info/Possible Solution		Field Measurements/Component Compliance

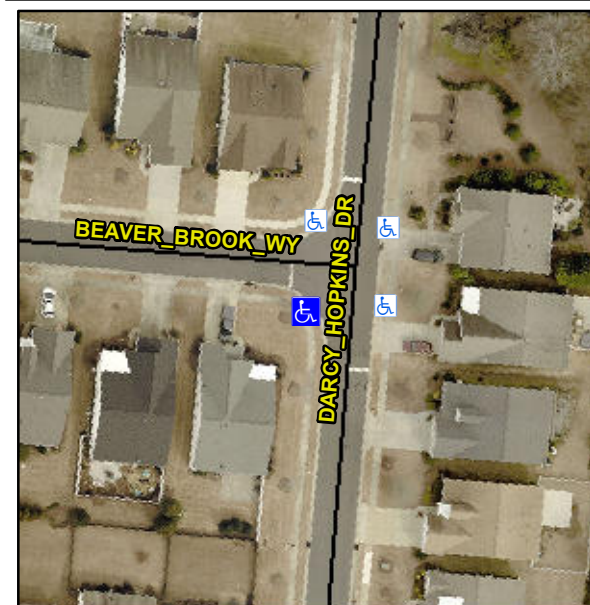
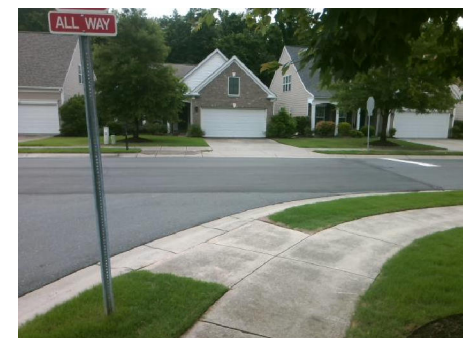
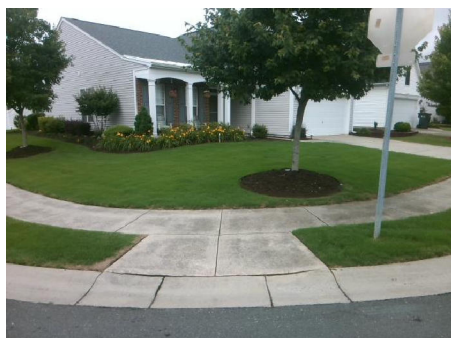
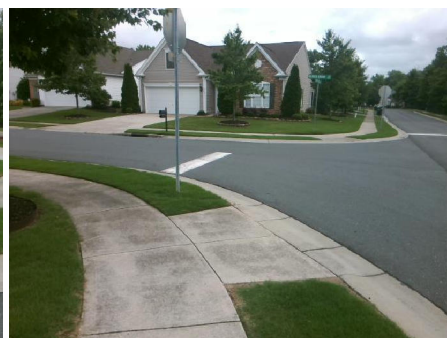
Not Found, R304.5.1, R304.5.3

Compliance	Description	Data	Compliance	Description	Data
N/A	Ramp Length (in)	46.0	Yes	Ramp Slope (%)	7.8
No	Ramp Width (in)	44.0	No	Ramp XSlope (%)	2.6
N/A	Flare Type LT	N/A	N/A	Flare Type RT	N/A
N/A	Flare Slope LT (%)	N/A	N/A	Flare Slope RT (%)	N/A
N/A	Flare Traversable LT?	N/A	N/A	Flare Traversable RT?	N/A
N/A	Landing Length (in)	N/A	N/A	DWS Provided?	N/A
N/A	Landing Width (in)	N/A	N/A	DWS Contrast?	N/A
N/A	Landing Slope (%)	N/A	N/A	DWS Length (in)	N/A
N/A	Landing X Slope (%)	N/A	N/A	DWS Full Width?	N/A
N/A	Landing Curb? (Y/N)	N/A	N/A	DWS Offset (in)	N/A
N/A	Shared Landing?	N/A			
N/A	Gutter Ponding?	N/A	N/A	Gutter Slope (%)	N/A
N/A	Gutter Lip Ht (in)	N/A	N/A	Gutter X Slope (%)	N/A
N/A	Painted X Walk1?	No	N/A	Painted X Walk2?	No
	X Walk 1 Direction	To SE		X Walk 2 Direction	To NE
N/A	X Walk 1 Width (in)	N/A	N/A	X Walk 2 Width (in)	N/A
	X Walk 1 Slope (%)	1.2		X Walk 2 Slope (%)	2.3
	X Walk 1 X Slope (%)	1.9		X Walk 2 X Slope (%)	0.9

N/A	Ramp inside XWalk1?	N/A	N/A	Ramp inside XWalk2?	N/A
	Road Slope (%)	1.8	N/A	Clear Space?	N/A
	Road X Slope (%)	2.4	N/A	Clear Space to XWalk (in)	N/A
N/A	Any Obstructions?	N/A	N/A	Storm Grate/Utility Hazard?	N/A
	Obstruction Type			Storm Grate/Utility Type	
		N/A			N/A
		Yes		Surface Condition? (G/P)	Good

Possible Solutions:

Remove & Replace Curb Ramp With Two New Directional Ramps or Equivalent.

Total Cost: \$ 3200.00
