## **Access Compliance Report Public Rights-of-Way** (Curb Ramps)

Intersection ID: 10014519 Main Street: UNIVERSITY\_POINTE\_BV Cross Street: N/A Location: SW **ADA ID: 4632DEA1A788** Ramp Type: Perp Initial Pass/Fail: Fail **Overall Compliance: No Severity Score:** 10

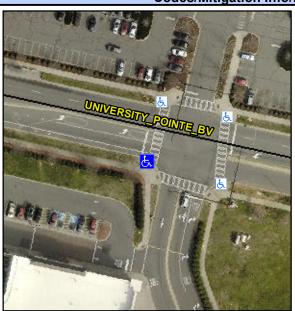
Good

/Possible Solution		Field Measurements/Component Compliance					
Possible Solutions:		Comp	liance Description	Data	Compli	ance Description	Data
Remove & Replace Entire F	Ramp.	N/A	Ramp Length (in)	102.5	Yes	Ramp Slope (%)	7.9

•	No	Ramp Width (in)	46.5	No	Ramp XSlope (%)	2.4
		N/A	Flare Type LT	N/A	N/A	Flare Type RT	N/A
		N/A	Flare Slope LT (%)	N/A	N/A	Flare Slope RT (%)	N/A
		N/A	Flare Traversable LT?	N/A	N/A	Flare Traversable RT?	N/A
		N/A	Landing Length (in)	N/A	N/A	DWS Provided?	N/A
Surveyor Notes:		N/A	Landing Width (in)	N/A	N/A	DWS Contrast?	N/A
N/A		N/A	Landing Slope (%)	N/A	N/A	DWS Length (in)	N/A
		N/A	Landing X Slope (%)	N/A	N/A	DWS Full Width?	N/A
		N/A	Landing Curb? (Y/N)	N/A	N/A	DWS Offset (in)	N/A
		N/A	Shared Landing?	N/A			
PROW/ADA:		N/A	Gutter Ponding?	N/A	N/A	Gutter Slope (%)	N/A
R304.5.1, R304.5.3		N/A	Gutter Lip Ht (in)	N/A	N/A	Gutter X Slope (%)	N/A
· ·		N/A	Painted X Walk1?	Yes	N/A	Painted X Walk2?	N/A
			X Walk 1 Direction	To N		X Walk 2 Direction	N/A
		N/A	X Walk 1 Width (in)	102.0	N/A	X Walk 2 Width (in)	N/A
			X Walk 1 Slope (%)	1.1		X Walk 2 Slope (%)	N/A
			X Walk 1 X Slope (%)	1.6		X Walk 2 X Slope (%)	N/A
