# Access Compliance Report

## Public Rights-of-Way

### (Curb Ramps)

Intersection ID: 18735	Main Street: JESTER_LN	Cross Street: REDCOAT_DR	Location: SE
ADA ID: 46345D1C4525	Ramp Type: PerpDiag	Initial Pass/Fail: Fail	Overall Compliance: No
Severity Score: 13.75			
Codes/Mitigation Info/Possible Solution		Field Measurements/Component Compliance

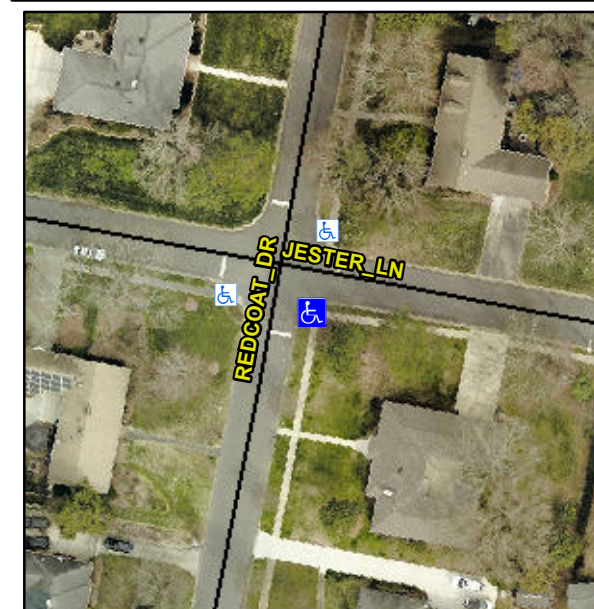
**Not Found, R304.2.2, R304.5.3**

Compliance	Description	Data	Compliance	Description	Data
N/A	Ramp Length (in)	75.0	No	Ramp Slope (%)	10.9
Yes	Ramp Width (in)	48.0	No	Ramp XSlope (%)	2.7
N/A	Flare Type LT	N/A	N/A	Flare Type RT	N/A
N/A	Flare Slope LT (%)	N/A	N/A	Flare Slope RT (%)	N/A
N/A	Flare Traversable LT?	N/A	N/A	Flare Traversable RT?	N/A
N/A	Landing Length (in)	N/A	N/A	DWS Provided?	N/A
N/A	Landing Width (in)	N/A	N/A	DWS Contrast?	N/A
N/A	Landing Slope (%)	N/A	N/A	DWS Length (in)	N/A
N/A	Landing X Slope (%)	N/A	N/A	DWS Full Width?	N/A
N/A	Landing Curb? (Y/N)	N/A	N/A	DWS Offset (in)	N/A
N/A	Shared Landing?	N/A			
N/A	Gutter Ponding?	N/A	N/A	Gutter Slope (%)	N/A
N/A	Gutter Lip Ht (in)	N/A	N/A	Gutter X Slope (%)	N/A
N/A	Painted X Walk1?	No	N/A	Painted X Walk2?	No
	X Walk 1 Direction	To NE		X Walk 2 Direction	To NW
N/A	X Walk 1 Width (in)	N/A	N/A	X Walk 2 Width (in)	N/A
	X Walk 1 Slope (%)	9.3		X Walk 2 Slope (%)	3.8
	X Walk 1 X Slope (%)	2.3		X Walk 2 X Slope (%)	6.0

N/A	Ramp inside XWalk1?	N/A	N/A	Ramp inside XWalk2?	N/A
	Road Slope (%)	3.0	N/A	Clear Space?	N/A
	Road X Slope (%)	8.4	N/A	Clear Space to XWalk (in)	N/A
N/A	Any Obstructions?	N/A	N/A	Storm Grate/Utility Hazard?	N/A
	Obstruction Type			Storm Grate/Utility Type	
		N/A			N/A
		Yes		Surface Condition? (G/P)	Good

**Remove & Replace Curb Ramp With Two New Directional Ramps or Equivalent.**
