Access Compliance Report Public Rights-of-Way (Curb Ramps)

Intersection ID: 30078 Main Street: SUNSET_RD Cross Street: WOODLANDS_POINTE_DR Location: NW **Severity Score:** ADA ID: 463F3324204E Ramp Type: Perp Initial Pass/Fail: Fail **Overall Compliance: No** 1.25

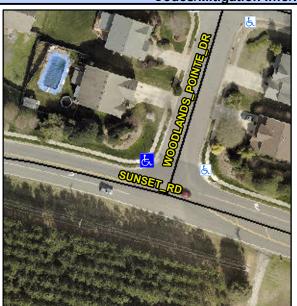
Field Measurements/Component Compliance								
Compliance Description		Data	Comp	liance	Description	Data		
N/A	Ramp Length (in)	74.0	Yes	Ram	Slope (%)	8.3		
Yes	Ramp Width (in)	48.0	No	Ramp XSlope (%)		2.9		
N/A	Flare Type LT	N/A	N/A	Flare Type RT		N/A		
N/A	Flare Slope LT (%)	N/A	N/A	Flare Slope RT (%)		N/A		
N/A	Flare Traversable LT?	N/A	N/A	Flare Traversable RT?		N/A		
N/A	Landing Length (in)	N/A	N/A	DWS	Provided?	N/A		
N/A	Landing Width (in)	N/A	N/A	DWS	Contrast?	N/A		
N/A	Landing Slope (%)	N/A	N/A	DWS	Length (in)	N/A		
N/A	Landing X Slope (%)	N/A	N/A	DWS	Full Width?	N/A		
N/A	Landing Curb? (Y/N)	N/A	N/A	DWS	Offset (in)	N/A		
N/A	Shared Landing?	N/A						
N/A	Gutter Ponding?	N/A	N/A	Gutte	er Slope (%)	N/A		
N/A	Gutter Lip Ht (in)	N/A	N/A	Gutte	er X Slope (%)	N/A		
N/A	Painted X Walk1?	No	N/A	Paint	ed X Walk2?	N/A		
	X Walk 1 Direction	To SE		X Wa	lk 2 Direction	N/A		
N/A	X Walk 1 Width (in)	N/A	N/A	X Wa	lk 2 Width (in)	N/A

X Walk 1 Slope (%)	3.1		X Wa	lk 2 Slope (%)	N/A		
	X Walk 1 X Slope (%)	5.7		X Wa	lk 2 X Slope (%)	N/A		
N/A	Ramp inside XWalk1?	N/A	N/A	Ram	o inside XWalk2?	N/A		
	Road Slope (%)	N/A	N/A	Clear	Space?	N/A		
	Road X Slope (%)	N/A	N/A	Clear	Space to XWalk (in)	N/A		
N/A	Any Obstructions?	N/A	N/A	Storn	n Grate/Utility Hazard?	N/A		
	Obstruction Type			Storn	n Grate/Utility Type			
		N/A				N/A		
			Yes	Surfa	ce Condition? (G/P)	Good

Possible Solution						
Possible Solutions:						
Remove & Replace Entire Ramp.						
Surveyor Notes:						
N/A						
PROW/ADA:						
R304.5.3

Total Cost: 1850.00
