Access Compliance Report

Public Rights-of-Way

(Curb Ramps)

Intersection ID: 51060	Main Street: CRAIGMOSS_LN	Cross Street: TIPPERLINN_WY	Location: SE
ADA ID: 4642CFB08C15	Ramp Type: Perp	Initial Pass/Fail: Pass	Overall Compliance: No
Codes/Mitigation Info/Possible Solution		Field Measurements/Component Compliance	
Severity Score: 2.5

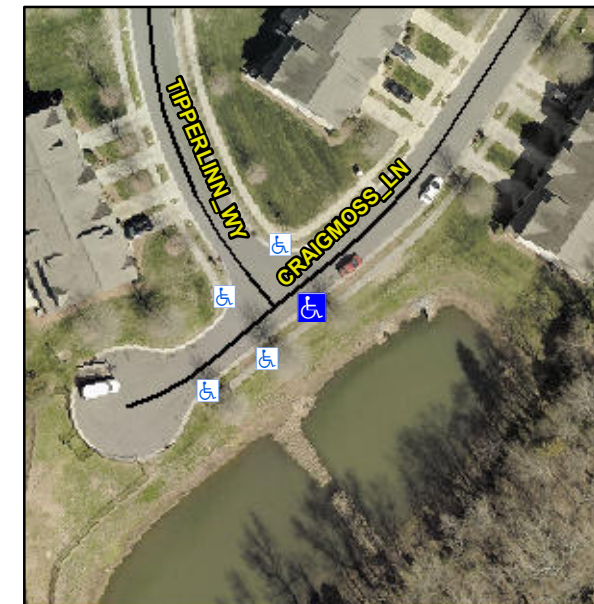
Compliance	Description	Data	Compliance	Description	Data
N/A	Ramp Length (in)	52.0	Yes	Ramp Slope (%)	6.4
Yes	Ramp Width (in)	48.0	Yes	Ramp XSlope (%)	0.1
N/A	Flare Type LT	Sloped	N/A	Flare Type RT	N/A
N/A	Flare Slope LT (%)	6.1	Yes	Flare Slope RT (%)	4.2
N/A	Flare Traversable LT?	Yes	N/A	Flare Traversable RT?	Yes
Yes	Landing Length (in)	48.0	Yes	DWS Provided?	Yes
Yes	Landing Width (in)	48.0	Yes	DWS Contrast?	Yes
No	Landing Slope (%)	2.7	Yes	DWS Length (in)	24.0
Yes	Landing X Slope (%)	1.2	No	DWS Full Width?	No
N/A	Landing Curb? (Y/N)	No	Yes	DWS Offset (in)	1.0
N/A	Shared Landing?	No			
Yes	Gutter Ponding?	No	Yes	Gutter Slope (%)	0.7
Yes	Gutter Lip Ht (in)	0.0	Yes	Gutter X Slope (%)	0.9
N/A	Painted X Walk1?	No	N/A	Painted X Walk2?	N/A
	X Walk 1 Direction	To NW		X Walk 2 Direction	N/A
N/A	X Walk 1 Width (in)	N/A	N/A	X Walk 2 Width (in)	N/A
	X Walk 1 Slope (%)	0.3		X Walk 2 Slope (%)	N/A
	X Walk 1 X Slope (%)	0.6		X Walk 2 X Slope (%)	N/A

N/A	Ramp inside XWalk1?	N/A	N/A	Ramp inside XWalk2?	N/A
	Road Slope (%)	N/A	N/A	Clear Space?	Yes
	Road X Slope (%)	N/A	N/A	Clear Space to XWalk (in)	N/A
Yes	Any Obstructions?	No	Yes	Storm Grate/Utility Hazard?	No
	Obstruction Type			Storm Grate/Utility Type	
		N/A			N/A
			Yes	Surface Condition? (G/P)	Good

Possible Solutions:

Remove & Replace Entire Ramp.
