# Access Compliance Report

## Public Rights-of-Way

### (Curb Ramps)

Intersection ID: N/A	Main Street: EASTWAY_DR	Cross Street: N/A	Location: NE
ADA ID: 464A74250207	Ramp Type: PerpDiag	Initial Pass/Fail: Fail	Overall Compliance: No
Codes/Mitigation Info/Possible Solution		Field Measurements/Component Compliance

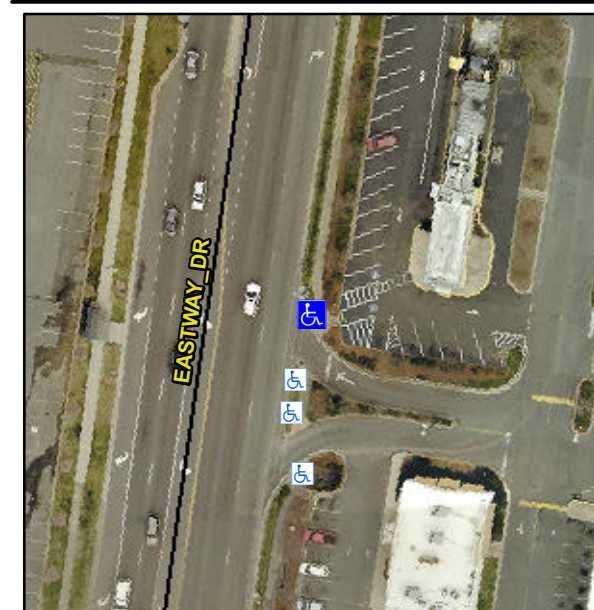
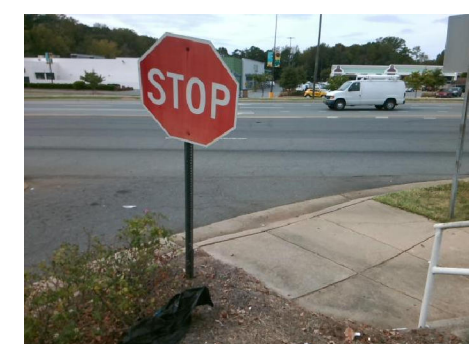
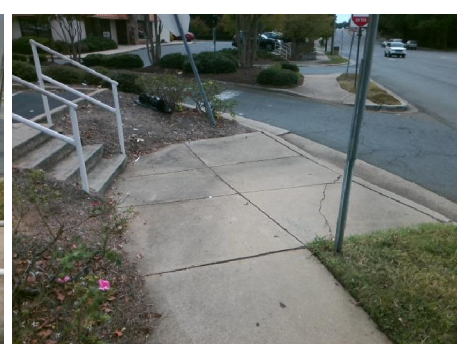
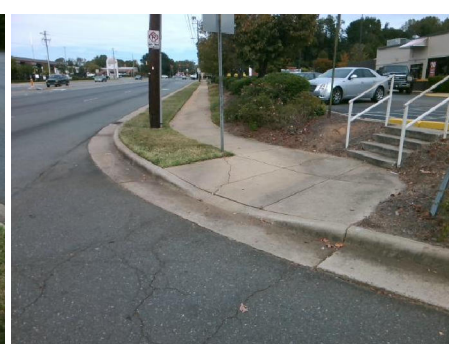
**Not Found, R304.5.1**

Compliance	Description	Data	Compliance	Description	Data
N/A	Ramp Length (in)	63.0	Yes	Ramp Slope (%)	5.3
No	Ramp Width (in)	37.0	Yes	Ramp XSlope (%)	2.0
N/A	Flare Type LT	N/A	N/A	Flare Type RT	N/A
N/A	Flare Slope LT (%)	N/A	N/A	Flare Slope RT (%)	N/A
N/A	Flare Traversable LT?	N/A	N/A	Flare Traversable RT?	N/A
N/A	Landing Length (in)	N/A	N/A	DWS Provided?	N/A
N/A	Landing Width (in)	N/A	N/A	DWS Contrast?	N/A
N/A	Landing Slope (%)	N/A	N/A	DWS Length (in)	N/A
N/A	Landing X Slope (%)	N/A	N/A	DWS Full Width?	N/A
N/A	Landing Curb? (Y/N)	N/A	N/A	DWS Offset (in)	N/A
N/A	Shared Landing?	N/A			
N/A	Gutter Ponding?	N/A	N/A	Gutter Slope (%)	N/A
N/A	Gutter Lip Ht (in)	N/A	N/A	Gutter X Slope (%)	N/A
N/A	Painted X Walk1?	No	N/A	Painted X Walk2?	No
	X Walk 1 Direction	To W		X Walk 2 Direction	To S
N/A	X Walk 1 Width (in)	N/A	N/A	X Walk 2 Width (in)	N/A
	X Walk 1 Slope (%)	2.8		X Walk 2 Slope (%)	0.4
	X Walk 1 X Slope (%)	2.5		X Walk 2 X Slope (%)	3.7

N/A	Ramp inside XWalk1?	N/A	N/A	Ramp inside XWalk2?	N/A
	Road Slope (%)	0.3	N/A	Clear Space?	N/A
	Road X Slope (%)	4.0	N/A	Clear Space to XWalk (in)	N/A
N/A	Any Obstructions?	N/A	N/A	Storm Grate/Utility Hazard?	N/A
	Obstruction Type			Storm Grate/Utility Type	
		N/A			N/A
			Yes	Surface Condition? (G/P)	Good

**Remove & Replace Curb Ramp With Two New Directional Ramps or Equivalent.**

Total Cost: \$ 3200.00
