Access Compliance Report

Public Rights-of-Way

(Curb Ramps)

Intersection ID: 46305	Main Street: AUGUSTINE_WY	Cross Street: BECKET RIDGE_RD	Location: NW
ADA ID: 464C3DDD2340	Ramp Type: PerpDiag	Initial Pass/Fail: Fail	Overall Compliance: No
Severity Score: 10			
Codes/Mitigation Info/Possible Solution		Field Measurements/Component Compliance

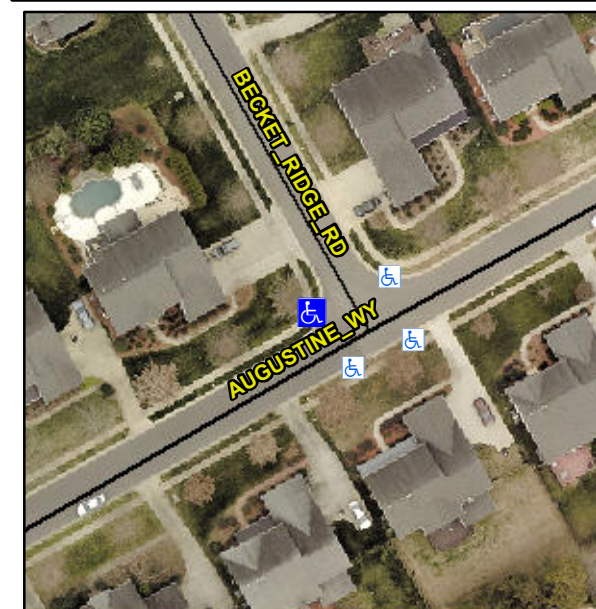
Not Found, R304.5.1, R304.5.3

Compliance	Description	Data	Compliance	Description	Data
N/A	Ramp Length (in)	50.0	Yes	Ramp Slope (%)	7.4
No	Ramp Width (in)	38.5	No	Ramp XSlope (%)	2.9
N/A	Flare Type LT	N/A	N/A	Flare Type RT	N/A
N/A	Flare Slope LT (%)	N/A	N/A	Flare Slope RT (%)	N/A
N/A	Flare Traversable LT?	N/A	N/A	Flare Traversable RT?	N/A
N/A	Landing Length (in)	N/A	N/A	DWS Provided?	N/A
N/A	Landing Width (in)	N/A	N/A	DWS Contrast?	N/A
N/A	Landing Slope (%)	N/A	N/A	DWS Length (in)	N/A
N/A	Landing X Slope (%)	N/A	N/A	DWS Full Width?	N/A
N/A	Landing Curb? (Y/N)	N/A	N/A	DWS Offset (in)	N/A
N/A	Shared Landing?	N/A			
N/A	Gutter Ponding?	N/A	N/A	Gutter Slope (%)	N/A
N/A	Gutter Lip Ht (in)	N/A	N/A	Gutter X Slope (%)	N/A
N/A	Painted X Walk1?	No	N/A	Painted X Walk2?	No
	X Walk 1 Direction	To S		X Walk 2 Direction	To E
N/A	X Walk 1 Width (in)	N/A	N/A	X Walk 2 Width (in)	N/A
	X Walk 1 Slope (%)	3.3		X Walk 2 Slope (%)	2.0
	X Walk 1 X Slope (%)	0.7		X Walk 2 X Slope (%)	4.4

N/A	Ramp inside XWalk1?	N/A	N/A	Ramp inside XWalk2?	N/A
	Road Slope (%)	2.9	N/A	Clear Space?	N/A
	Road X Slope (%)	3.8	N/A	Clear Space to XWalk (in)	N/A
N/A	Any Obstructions?	N/A	N/A	Storm Grate/Utility Hazard?	N/A
	Obstruction Type			Storm Grate/Utility Type	
		N/A			N/A
		Yes		Surface Condition? (G/P)	Good

Remove & Replace Curb Ramp With Two New Directional Ramps or Equivalent.
