Access Compliance Report

Public Rights-of-Way

(Curb Ramps)

Intersection ID: 10033070	Main Street: NORTH_COMMUNITY_HOUSE_RD	Cross Street: N/A	Location: SW
ADA ID: 464F8C787615	Ramp Type: Para	Initial Pass/Fail: Fail	Overall Compliance: No
Severity Score: 13.75			
Codes/Mitigation Info/Possible Solution		Field Measurements/Component Compliance

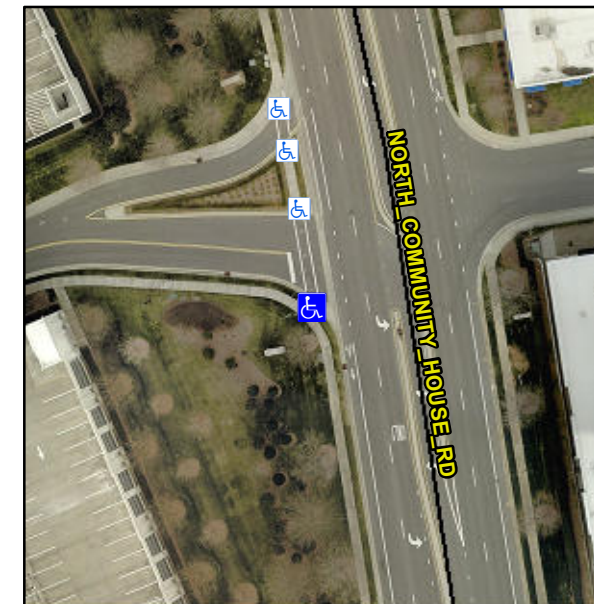
R304.5.3, R304.3.2

Compliance	Description	Data	Compliance	Description	Data
N/A	Ramp Length LT (in)	54.0	N/A	Ramp Length RT (in)	63.0
Yes	Ramp Width LT (in)	58.5	Yes	Ramp Width RT (in)	58.0
Yes	Ramp Slope LT (%)	8.2	No	Ramp Slope RT (%)	9.5
No	Ramp XSlope LT (%)	2.1	Yes	Ramp XSlope RT (%)	2.0
N/A	Landing Length (in)	N/A	N/A	DWS Provided?	N/A
N/A	Landing Width (in)	N/A	N/A	DWS Contrast?	N/A
N/A	Landing Slope (%)	N/A	N/A	DWS Length (in)	N/A
N/A	Landing X Slope (%)	N/A	N/A	DWS Full Width?	N/A
N/A	Landing Curb? (Y/N)	N/A	N/A	DWS Offset (in)	N/A
N/A	Shared Landing?	N/A			
N/A	Gutter Ponding?	N/A	N/A	Gutter Slope (%)	N/A
N/A	Gutter Lip Ht (in)	N/A	N/A	Gutter X Slope (%)	N/A
N/A	Painted X Walk1?	Yes	N/A	Painted X Walk2?	N/A
	X Walk 1 Direction	To NW		X Walk 2 Direction	N/A
N/A	X Walk 1 Width (in)	75.0	N/A	X Walk 2 Width (in)	N/A
	X Walk 1 Slope (%)	1.3		X Walk 2 Slope (%)	N/A
	X Walk 1 X Slope (%)	4.0		X Walk 2 X Slope (%)	N/A
N/A	Ramp inside XWalk1?	Yes	N/A	Ramp inside XWalk2?	N/A

Road Slope (%)	N/A	N/A	Clear Space?	N/A
	Road X Slope (%)	N/A	N/A	Clear Space to XWalk (in)	N/A
N/A	Any Obstructions?	N/A	N/A	Storm Grate/Utility Hazard?	N/A
	Obstruction Type			Storm Grate/Utility Type	
		N/A			N/A
			Yes	Surface Condition? (G/P)	Good
			N/A	Curb Slope (%)	6.9

Possible Solutions:

Remove & Replace Entire Ramp.

Total Cost: \$ 1600.00
