Access Compliance Report

Public Rights-of-Way

(Curb Ramps)

Intersection ID: N/A	Main Street: SPEER_BV	Cross Street: MILLENNIUM_AV	Location: NW
ADA ID: 465035479726	Ramp Type: Directional1	Initial Pass/Fail: Fail	Overall Compliance: No
Codes/Mitigation Info/Possible Solution		Field Measurements/Component Compliance

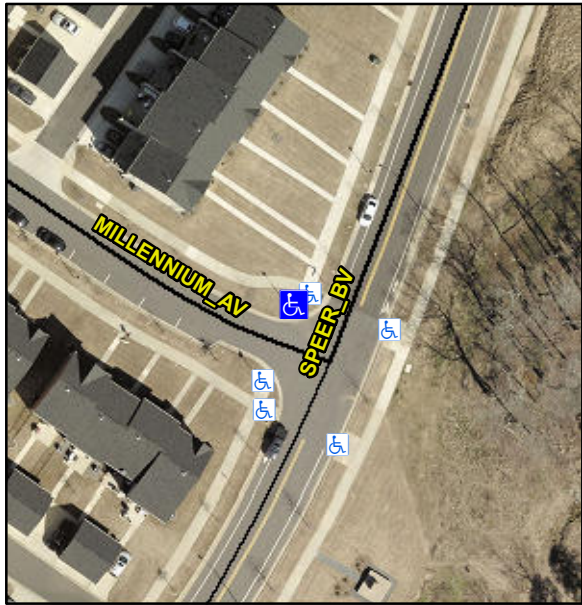
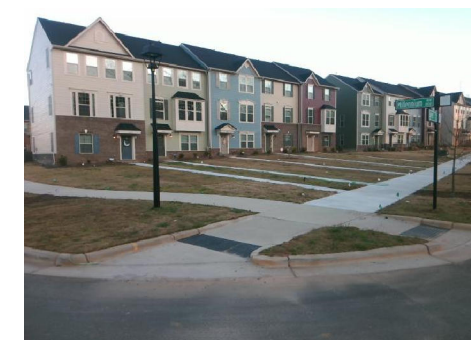
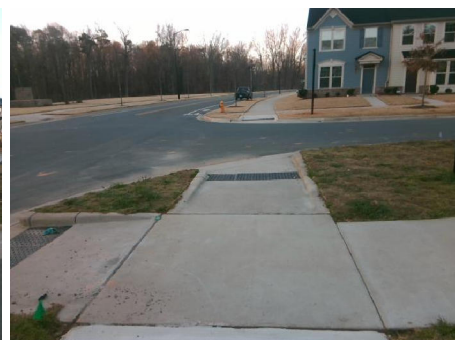
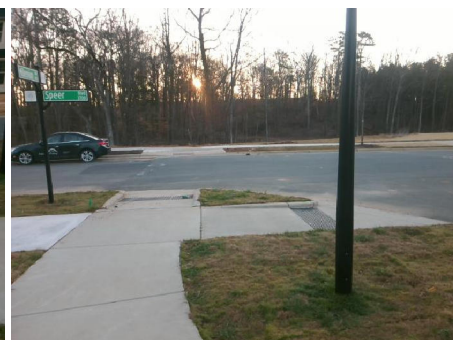
Compliance	Description	Data	Compliance	Description	Data
N/A	Ramp Length (in)	97.0	N/A	Grade Break?	N/A
Yes	Ramp Width (in)	69.0	N/A	Grade Break Slope (%)	0.0
Yes	Ramp Slope (%)	6.2	N/A	Grade Break XSlope (%)	0.0
No	Ramp XSlope (%)	2.4			
N/A	Flare Type LT	N/A	N/A	Flare Type RT	N/A
N/A	Flare Slope LT (%)	N/A	N/A	Flare Slope RT (%)	0.0
N/A	Flare Traversable LT?	N/A	N/A	Flare Traversable RT?	N/A
N/A	Landing Length (in)	0.0	N/A	DWS Provided?	N/A
N/A	Landing Width (in)	0.0	N/A	DWS Contrast?	N/A
N/A	Landing Slope (%)	0.0	N/A	DWS Length (in)	N/A
N/A	Landing X Slope (%)	0.0	N/A	DWS Full Width?	N/A
N/A	Landing Curb? (Y/N)	N/A	N/A	DWS Offset LT (in)	N/A
N/A	Shared Landing?	N/A	N/A	DWS Offset RT (in)	N/A
N/A	Gutter Ponding?	0.0	N/A	Gutter Slope (%)	N/A
N/A	Gutter Lip Ht (in)	0.0	N/A	Gutter X Slope (%)	N/A
N/A	Painted X Walk1?	No		Road Slope (%)	2.1
	X Walk 1 Direction	To S		Road X Slope (%)	0.3
	X Walk 1 Width (in)	N/A		Clear Space?	N/A

X Walk 1 Slope (%)	2.1	N/A	Clear Space to XWalk (in)	N/A
	X Walk 1 X Slope (%)	0.3	N/A	Storm Grate/Utility Hazard?	N/A
N/A	Ramp inside XWalk1?	N/A		Storm Grate/Utility Type	
N/A	Any Obstructions?	N/A			N/A
	Obstruction Type		Yes	Surface Condition? (G/P)	Good
		N/A	N/A	Curb Slope (%)	3.3

Possible Solutions:

Remove & Replace Entire Ramp.

R304.5.3
