# Access Compliance Report

## Public Rights-of-Way

### (Curb Ramps)

Intersection ID: 25670	Main Street: EDGEWOOD GROVE TL	Cross Street: WOODLEIGH OAKS DR	Location: NE
ADA ID: 46505FD1E804	Ramp Type: Perp	Initial Pass/Fail: Fail	Overall Compliance: No
Severity Score: 22.5			
Codes/Mitigation Info/Possible Solution		Field Measurements/Component Compliance

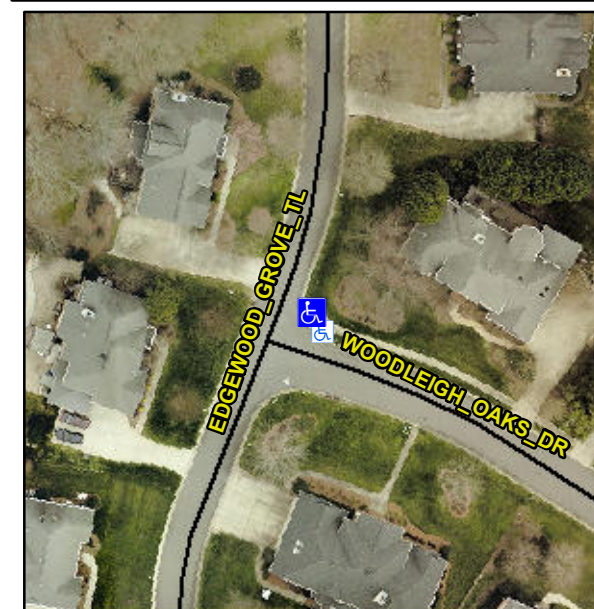
**Not Found, R304.5.1, R304.2.2, R304.5.3**

Compliance	Description	Data	Compliance	Description	Data
N/A	Ramp Length (in)	47.0	No	Ramp Slope (%)	9.0
No	Ramp Width (in)	45.0	No	Ramp XSlope (%)	3.2
N/A	Flare Type LT	N/A	N/A	Flare Type RT	N/A
N/A	Flare Slope LT (%)	N/A	N/A	Flare Slope RT (%)	N/A
N/A	Flare Traversable LT?	N/A	N/A	Flare Traversable RT?	N/A
N/A	Landing Length (in)	N/A	N/A	DWS Provided?	N/A
N/A	Landing Width (in)	N/A	N/A	DWS Contrast?	N/A
N/A	Landing Slope (%)	N/A	N/A	DWS Length (in)	N/A
N/A	Landing X Slope (%)	N/A	N/A	DWS Full Width?	N/A
N/A	Landing Curb? (Y/N)	N/A	N/A	DWS Offset (in)	N/A
N/A	Shared Landing?	N/A			
N/A	Gutter Ponding?	N/A	N/A	Gutter Slope (%)	N/A
N/A	Gutter Lip Ht (in)	N/A	N/A	Gutter X Slope (%)	N/A
N/A	Painted X Walk1?	No	N/A	Painted X Walk2?	N/A
	X Walk 1 Direction	To SW		X Walk 2 Direction	N/A
N/A	X Walk 1 Width (in)	N/A	N/A	X Walk 2 Width (in)	N/A
	X Walk 1 Slope (%)	2.2		X Walk 2 Slope (%)	N/A
	X Walk 1 X Slope (%)	1.4		X Walk 2 X Slope (%)	N/A

N/A	Ramp inside XWalk1?	N/A	N/A	Ramp inside XWalk2?	N/A
	Road Slope (%)	N/A	N/A	Clear Space?	N/A
	Road X Slope (%)	N/A	N/A	Clear Space to XWalk (in)	N/A
N/A	Any Obstructions?	N/A	N/A	Storm Grate/Utility Hazard?	N/A
	Obstruction Type			Storm Grate/Utility Type	
		N/A			N/A
			Yes	Surface Condition? (G/P)	Good

**Remove & Replace Entire Ramp.**
