Access Compliance Report

Public Rights-of-Way

(Curb Ramps)

Intersection ID: 21295	Main Street: PARK_SOUTH_DR	Cross Street: CYPRESS_CLUB_DR	Location: W
ADA ID: 465CFB25358C	Ramp Type: PerpDiag	Initial Pass/Fail: Pass	Overall Compliance: No
		Severity Score: 0.25

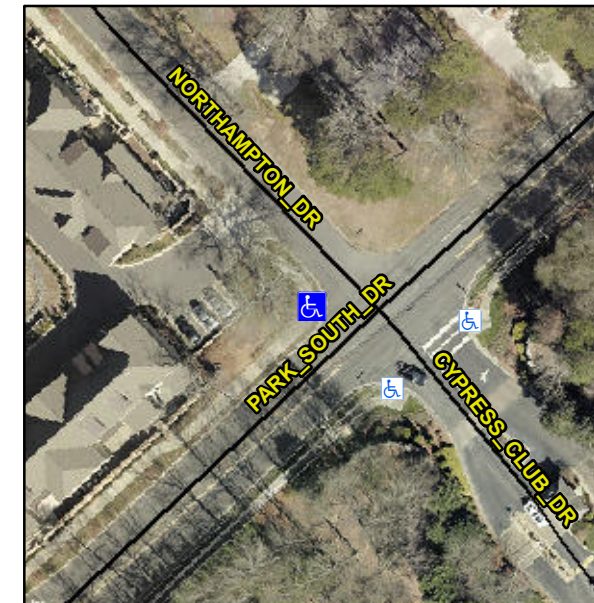
Not Found, R304.5.3, R305.2

Compliance	Description	Data	Compliance	Description	Data
N/A	Ramp Length (in)	32.0	Yes	Ramp Slope (%)	6.3
Yes	Ramp Width (in)	48.0	No	Ramp XSlope (%)	3.2
N/A	Flare Type LT	Sloped	N/A	Flare Type RT	N/A
N/A	Flare Slope LT (%)	0.5	Yes	Flare Slope RT (%)	5.1
N/A	Flare Traversable LT?	Yes	N/A	Flare Traversable RT?	Yes
Yes	Landing Length (in)	67.0	Yes	DWS Provided?	Yes
Yes	Landing Width (in)	48.0	Yes	DWS Contrast?	Yes
Yes	Landing Slope (%)	0.7	Yes	DWS Length (in)	24.0
No	Landing X Slope (%)	3.9	Yes	DWS Full Width?	Yes
N/A	Landing Curb? (Y/N)	No	No	DWS Offset (in)	5.0
N/A	Shared Landing?	No			
Yes	Gutter Ponding?	No	Yes	Gutter Slope (%)	2.6
Yes	Gutter Lip Ht (in)	0.0	No	Gutter X Slope (%)	2.7
N/A	Painted X Walk1?	No	N/A	Painted X Walk2?	No
	X Walk 1 Direction	To SE		X Walk 2 Direction	To NE
N/A	X Walk 1 Width (in)	N/A	N/A	X Walk 2 Width (in)	N/A
	X Walk 1 Slope (%)	8.5		X Walk 2 Slope (%)	5.5
	X Walk 1 X Slope (%)	7.5		X Walk 2 X Slope (%)	0.9

N/A	Ramp inside XWalk1?	N/A	N/A	Ramp inside XWalk2?	N/A
	Road Slope (%)	1.6	N/A	Clear Space?	Yes
	Road X Slope (%)	10.5	N/A	Clear Space to XWalk (in)	N/A
Yes	Any Obstructions?	No	Yes	Storm Grate/Utility Hazard?	No
	Obstruction Type			Storm Grate/Utility Type	
		N/A			N/A
			Yes	Surface Condition? (G/P)	Good

Possible Solutions:

Remove & Replace Curb Ramp With Two New Directional Ramps or Equivalent. Remove & Replace Gutter.
