# Access Compliance Report

## Public Rights-of-Way

### (Curb Ramps)

Intersection ID: 31526	Main Street: WILGROVE WAY DR	Cross Street: CARLEEN WAY DR	Location: S
ADA ID: 4671B311D013	Ramp Type: BlendTrans1	Initial Pass/Fail: Fail	Overall Compliance: No
		Severity Score: 17.5

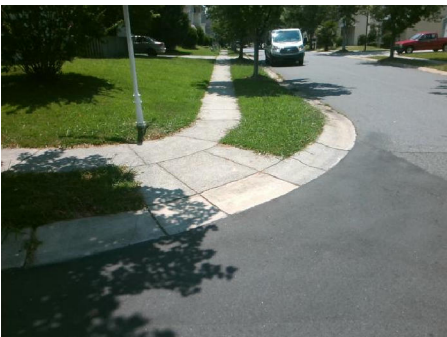
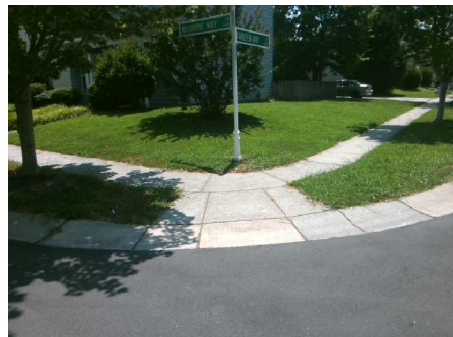
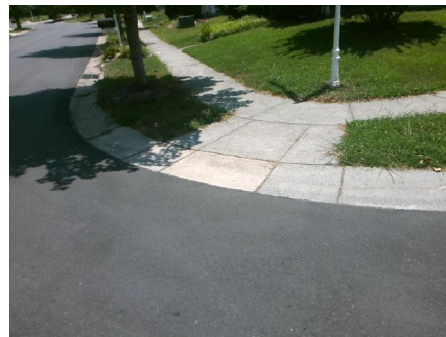
**Not Found, R304.5.1**

Compliance	Description	Data	Compliance	Description	Data
N/A	Ramp Length (in)	46.0	Yes	BlendTrans Slope (%)	4.7
No	Ramp Width (in)	33.0	Yes	BlendTrans XSlope (%)	0.4
N/A	Flare Type LT	N/A	N/A	Flare Type RT	N/A
N/A	Flare Slope LT (%)	N/A	N/A	Flare Slope RT (%)	N/A
N/A	Flare Traversable LT?	N/A	N/A	Flare Traversable RT?	N/A
N/A	Landing Length (in)	N/A	N/A	DWS Provided?	N/A
N/A	Landing Width (in)	N/A	N/A	DWS Contrast?	N/A
N/A	Landing Slope (%)	N/A	N/A	DWS Length (in)	N/A
N/A	Landing X Slope (%)	N/A	N/A	DWS Full Width?	N/A
N/A	Landing Curb? (Y/N)	N/A	N/A	DWS Offset (in)	N/A
N/A	Shared Landing?	N/A			
N/A	Gutter Ponding?	N/A	N/A	Gutter Slope (%)	N/A
N/A	Gutter Lip Ht (in)	N/A	N/A	Gutter X Slope (%)	N/A
N/A	Painted X Walk1?	No	N/A	Painted X Walk2?	No
	X Walk 1 Direction	To NE		X Walk 2 Direction	To NW
	X Walk 1 Width (in)	N/A		X Walk 2 Width (in)	N/A
	X Walk 1 Slope (%)	1.4		X Walk 2 Slope (%)	2.1
	X Walk 1 X Slope (%)	0.7		X Walk 2 X Slope (%)	1.2

N/A	Ramp inside XWalk1?	N/A	N/A	Ramp inside XWalk2?	N/A
	Road Slope (%)	0.5		Clear Space?	N/A
	Road X Slope (%)	0.1	N/A	Clear Space to XWalk (in)	N/A
N/A	Any Obstructions?	N/A	N/A	Storm Grate/Utility Hazard?	N/A
	Obstruction Type			Storm Grate/Utility Type	
		N/A			N/A
			Yes	Surface Condition? (G/P)	Good
			No	Curb Slope (%)	10.5

**Remove & Replace Curb Ramp With Two New Directional Ramps or Equivalent.**
