Access Compliance Report

Public Rights-of-Way

(Curb Ramps)

Intersection ID: 10029063	Main Street: ISABEL_CT	Cross Street: N/A	Location: N
ADA ID: 469B93CC2A3A	Ramp Type: PerpDiag	Initial Pass/Fail: Fail	Overall Compliance: No
			Severity Score: 13.75

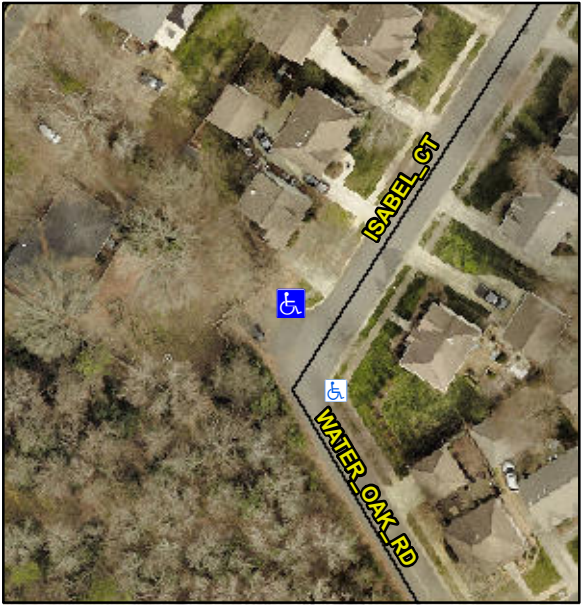
Possible Solutions:	Remove & Replace Curb Ramp With Two New Directional Ramps or Equivalent.					
	Surveyor Notes:	N/A					
	PROW/ADA:	Not Found, R304.2.2, R304.5.3					
			Compliance	Description	Data	Compliance	Description
			N/A	Ramp Length (in)	48.0	No	Ramp Slope (%)
			Yes	Ramp Width (in)	48.0	No	Ramp XSlope (%)
			N/A	Flare Type LT	N/A	N/A	Flare Type RT
			N/A	Flare Slope LT (%)	N/A	N/A	Flare Slope RT (%)
			N/A	Flare Traversable LT?	N/A	N/A	Flare Traversable RT?
			N/A	Landing Length (in)	N/A	N/A	DWS Provided?
			N/A	Landing Width (in)	N/A	N/A	DWS Contrast?
			N/A	Landing Slope (%)	N/A	N/A	DWS Length (in)
			N/A	Landing X Slope (%)	N/A	N/A	DWS Full Width?
			N/A	Landing Curb? (Y/N)	N/A	N/A	DWS Offset (in)
			N/A	Shared Landing?	N/A		
			N/A	Gutter Ponding?	N/A	N/A	Gutter Slope (%)
			N/A	Gutter Lip Ht (in)	N/A	N/A	Gutter X Slope (%)

N/A	Painted X Walk1?	No	N/A	Painted X Walk2?
				X Walk 1 Direction	To W		X Walk 2 Direction
			N/A	X Walk 1 Width (in)	N/A	N/A	X Walk 2 Width (in)
				X Walk 1 Slope (%)	7.2		X Walk 2 Slope (%)
				X Walk 1 X Slope (%)	2.4		X Walk 2 X Slope (%)
			N/A	Ramp inside XWalk1?	N/A	N/A	Ramp inside XWalk2?
				Road Slope (%)	0.7	N/A	Clear Space?
				Road X Slope (%)	7.7	N/A	Clear Space to XWalk (in)
			N/A	Any Obstructions?	N/A	N/A	Storm Grate/Utility Hazard?
				Obstruction Type			Storm Grate/Utility Type
					N/A		N/A
						Yes	Surface Condition? (G/P)
							Good
