# Access Compliance Report

## Public Rights-of-Way

### (Curb Ramps)

Intersection ID: 11911	Main Street: W_7TH_ST	Cross Street: N_CHURCH_ST	Location: S
ADA ID: 46AB7955D257	Ramp Type: PerpDiag	Initial Pass/Fail: Fail	Overall Compliance: No
		Severity Score: 12.5

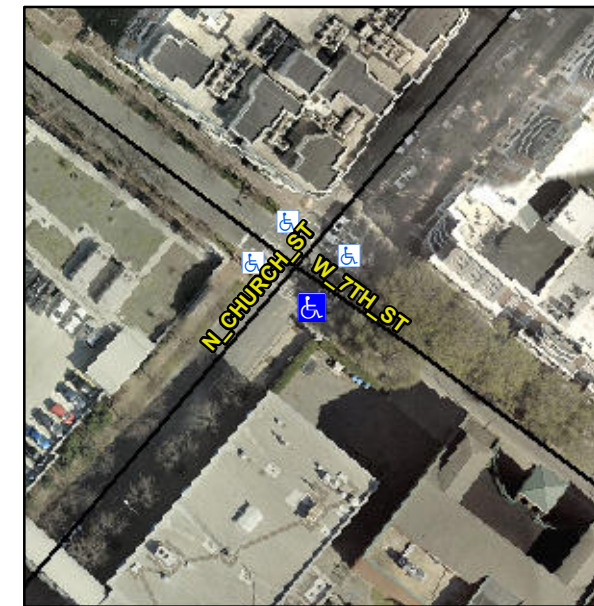
Compliance	Description	Data	Compliance	Description	Data
N/A	Ramp Length (in)	72.0	Yes	Ramp Slope (%)	6.1
Yes	Ramp Width (in)	48.0	No	Ramp XSlope (%)	6.9
N/A	Flare Type LT	N/A	N/A	Flare Type RT	N/A
N/A	Flare Slope LT (%)	N/A	N/A	Flare Slope RT (%)	N/A
N/A	Flare Traversable LT?	N/A	N/A	Flare Traversable RT?	N/A
N/A	Landing Length (in)	N/A	N/A	DWS Provided?	N/A
N/A	Landing Width (in)	N/A	N/A	DWS Contrast?	N/A
N/A	Landing Slope (%)	N/A	N/A	DWS Length (in)	N/A
N/A	Landing X Slope (%)	N/A	N/A	DWS Full Width?	N/A
N/A	Landing Curb? (Y/N)	N/A	N/A	DWS Offset (in)	N/A
N/A	Shared Landing?	N/A			
N/A	Gutter Ponding?	N/A	N/A	Gutter Slope (%)	N/A
N/A	Gutter Lip Ht (in)	N/A	N/A	Gutter X Slope (%)	N/A
N/A	Painted X Walk1?	Yes	N/A	Painted X Walk2?	Yes
	X Walk 1 Direction	To NE		X Walk 2 Direction	To NW
N/A	X Walk 1 Width (in)	109.0	N/A	X Walk 2 Width (in)	86.0
	X Walk 1 Slope (%)	1.3		X Walk 2 Slope (%)	3.2
	X Walk 1 X Slope (%)	0.3		X Walk 2 X Slope (%)	3.9

N/A	Ramp inside XWalk1?	Yes	N/A	Ramp inside XWalk2?	Yes
	Road Slope (%)	9.4	N/A	Clear Space?	N/A
	Road X Slope (%)	1.2	N/A	Clear Space to XWalk (in)	N/A
N/A	Any Obstructions?	N/A	N/A	Storm Grate/Utility Hazard?	N/A
	Obstruction Type			Storm Grate/Utility Type	
		N/A			N/A
		Yes		Surface Condition? (G/P)	Good

**Remove & Replace Curb Ramp With Two New Directional Ramps or Equivalent.**

**R304.5.3**

Total Cost: \$ 3200.00
