Access Compliance Report

Public Rights-of-Way

(Curb Ramps)

Intersection ID: 20923	Main Street: LANSLOWNE_RD	Cross Street: OWENBY_CT	Location: E
ADA ID: 46B461D68C28	Ramp Type: PerpDiag	Initial Pass/Fail: Fail	Overall Compliance: No
Codes/Mitigation Info/Possible Solution		Field Measurements/Component Compliance	
Severity Score: 13.75

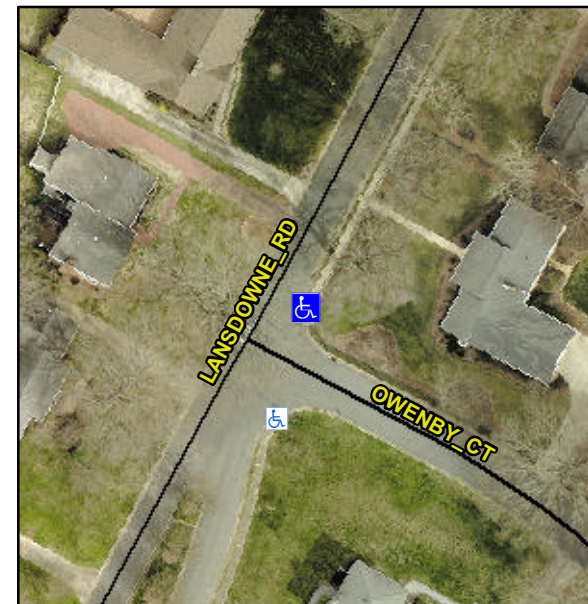
Not Found, R304.2.2, R304.5.3

Compliance	Description	Data	Compliance	Description	Data
N/A	Ramp Length (in)	48.0	No	Ramp Slope (%)	10.4
Yes	Ramp Width (in)	48.0	No	Ramp XSlope (%)	2.4
N/A	Flare Type LT	N/A	N/A	Flare Type RT	N/A
N/A	Flare Slope LT (%)	N/A	N/A	Flare Slope RT (%)	N/A
N/A	Flare Traversable LT?	N/A	N/A	Flare Traversable RT?	N/A
N/A	Landing Length (in)	N/A	N/A	DWS Provided?	N/A
N/A	Landing Width (in)	N/A	N/A	DWS Contrast?	N/A
N/A	Landing Slope (%)	N/A	N/A	DWS Length (in)	N/A
N/A	Landing X Slope (%)	N/A	N/A	DWS Full Width?	N/A
N/A	Landing Curb? (Y/N)	N/A	N/A	DWS Offset (in)	N/A
N/A	Shared Landing?	N/A			
N/A	Gutter Ponding?	N/A	N/A	Gutter Slope (%)	N/A
N/A	Gutter Lip Ht (in)	N/A	N/A	Gutter X Slope (%)	N/A
N/A	Painted X Walk1?	No	N/A	Painted X Walk2?	No
	X Walk 1 Direction	To NW		X Walk 2 Direction	To SW
N/A	X Walk 1 Width (in)	N/A	N/A	X Walk 2 Width (in)	N/A
	X Walk 1 Slope (%)	5.8		X Walk 2 Slope (%)	1.1
	X Walk 1 X Slope (%)	1.4		X Walk 2 X Slope (%)	1.7

N/A	Ramp inside XWalk1?	N/A	N/A	Ramp inside XWalk2?	N/A
	Road Slope (%)	3.3	N/A	Clear Space?	N/A
	Road X Slope (%)	3.4	N/A	Clear Space to XWalk (in)	N/A
N/A	Any Obstructions?	N/A	N/A	Storm Grate/Utility Hazard?	N/A
	Obstruction Type			Storm Grate/Utility Type	
		N/A			N/A
			Yes	Surface Condition? (G/P)	Good

Possible Solutions:

Remove & Replace Curb Ramp With Two New Directional Ramps or Equivalent.
